**Conditions Study for  
Park Union Study Area  
Colorado Springs, Colorado**

DRAFT

February 2022

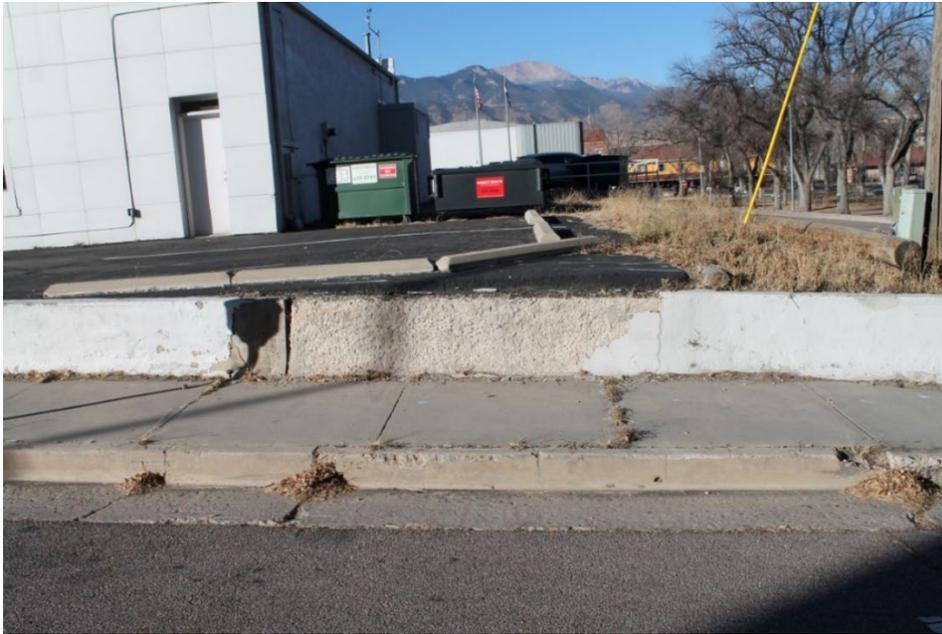
**Figure 2-1 Deteriorated retaining walls/loading docks, poor parking lot layout, cracked or uneven pedestrian surfaces, unsafe level changes, deteriorated curb and gutter, inadequate and deteriorated sidewalk, trash and debris, inadequate site maintenance, non-conformance to development regulations (Photo A-1)**

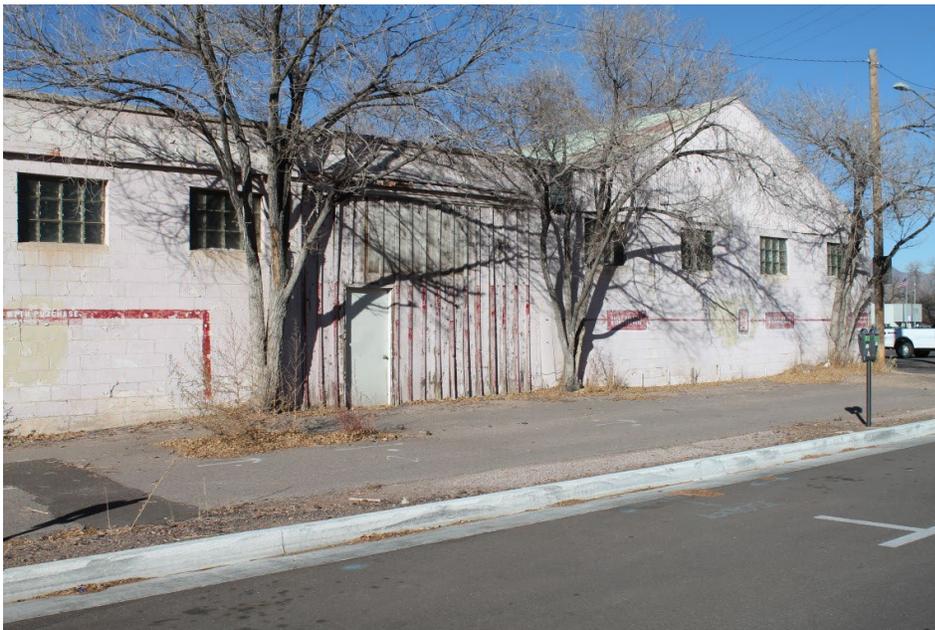
**Figure 2-2 Deteriorated exterior walls, fascia, finishes, and windows, cracked or uneven pedestrian surfaces, trash and debris, deteriorated curb and gutter, inadequate and deteriorated sidewalk, inadequate site maintenance, non-conformance to development regulations (Photo A-15)**

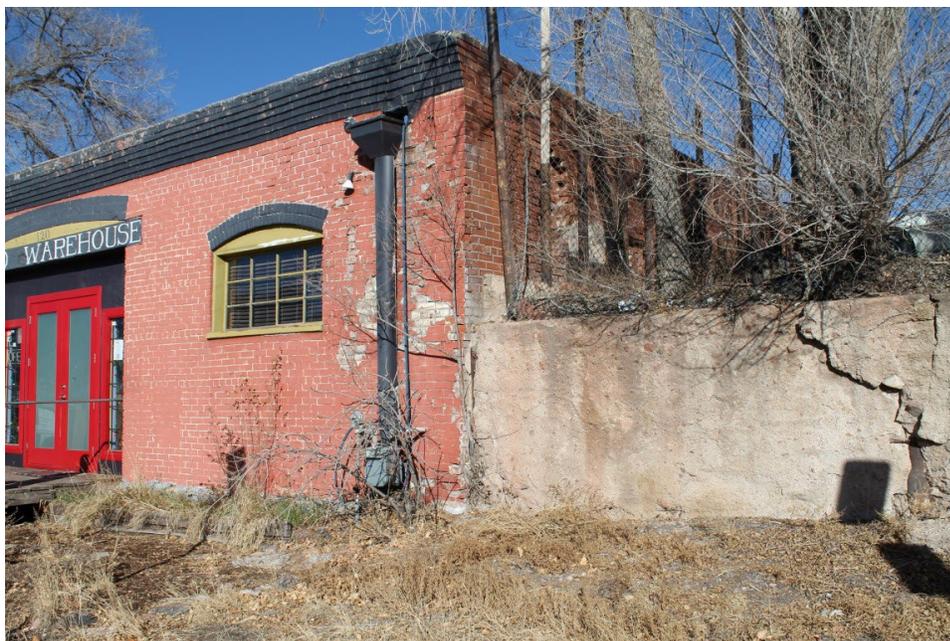
**Figure 2-3 Deteriorated exterior walls, fascia, finishes, windows, gutters and downspouts, deteriorated retaining walls/fences, cracked or uneven pedestrian surfaces, trash and debris, inadequate and deteriorated sidewalk, inadequate site maintenance, non-conformance to development regulations (Photo A-17)**

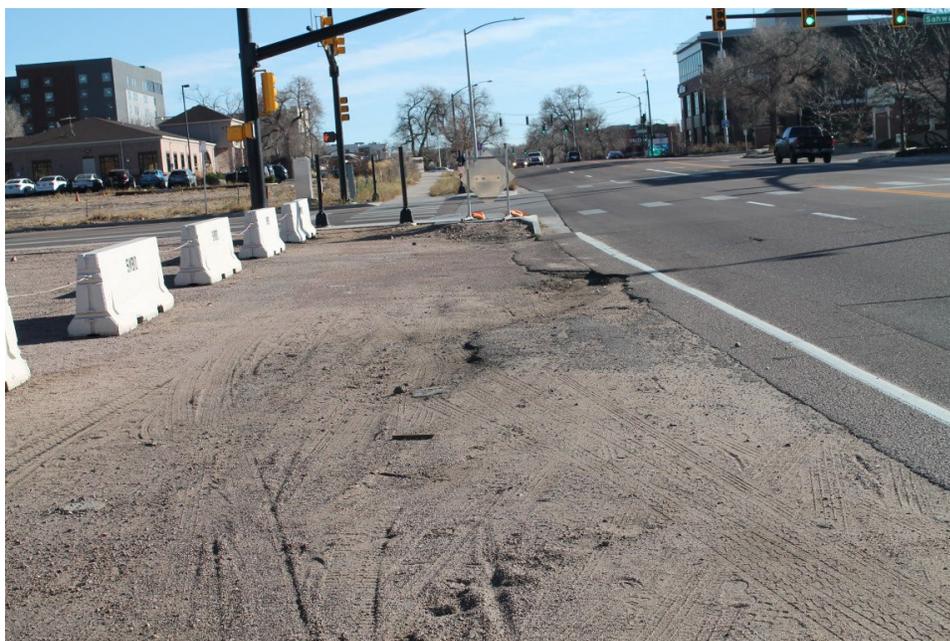
**Figure 2-4 Substandard driveway/curb cuts, cracked and uneven surfaces, unsafe level changes, inadequate surface drainage, deteriorated curb and gutter, inadequate and deteriorated sidewalk, inadequate site maintenance, non-conformance to development regulations (Photo A-24)**

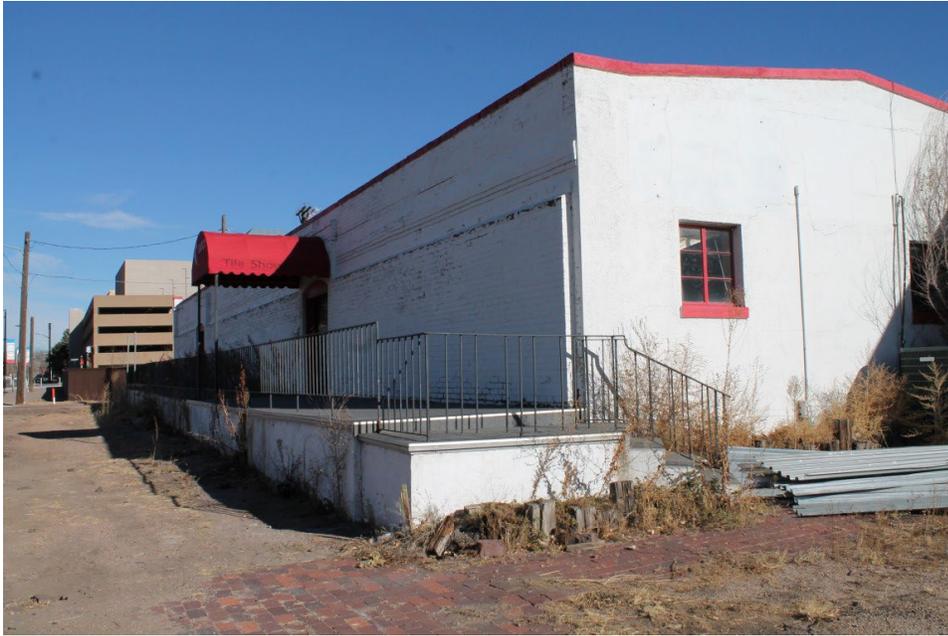
**Figure 2-5 Deteriorated retaining walls/loading docks, poor parking lot layout, cracked or uneven pedestrian surfaces, unsafe level changes, deteriorated curb and gutter, lack of sidewalks, inadequate sidewalk, trash and debris, unsafe level changes, potentially hazardous conditions, inadequate site maintenance, non-conformance to development regulations (Photo A-32)**

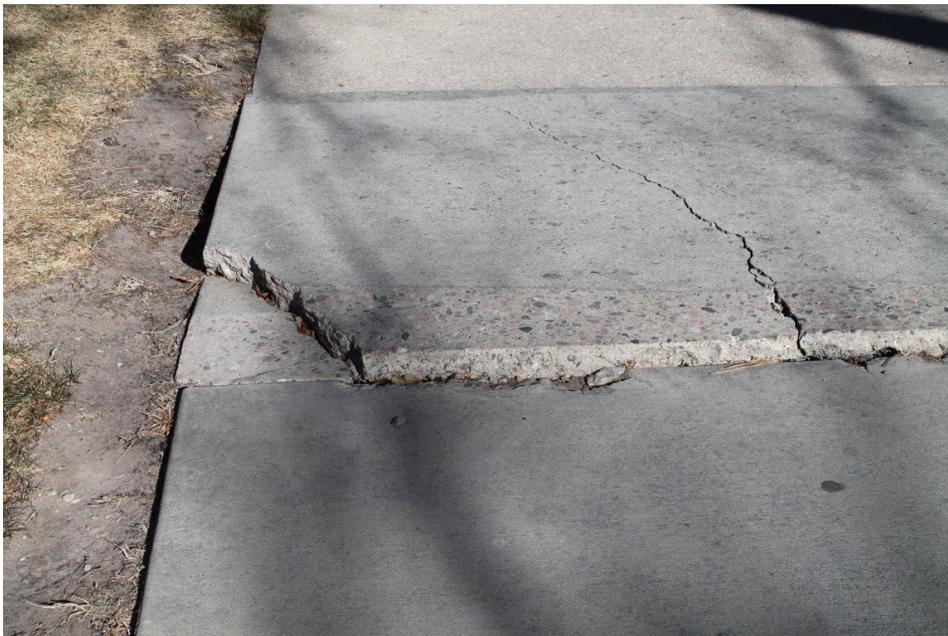
**Figure 2-6 Cracked or uneven pedestrian surfaces, deteriorated sidewalk, unsafe level changes, potentially hazardous conditions, inadequate site maintenance (Photo A-38)**

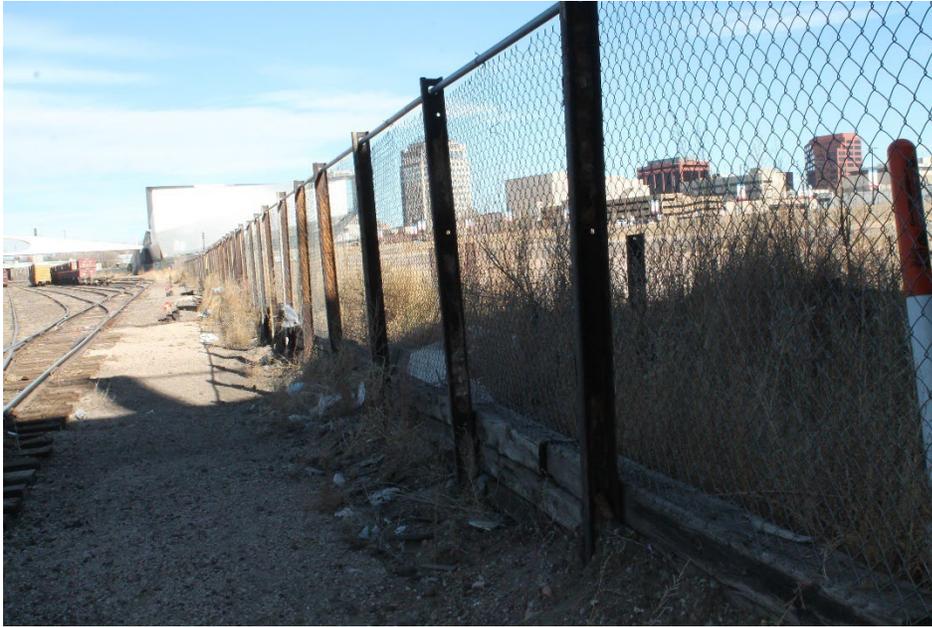
**Figure 2-7 Deteriorated fences/walls, cracked or uneven pedestrian surfaces, deteriorated sidewalk, unsafe level changes, trash and debris, potentially hazardous conditions, inadequate site maintenance (Photo B-3)**

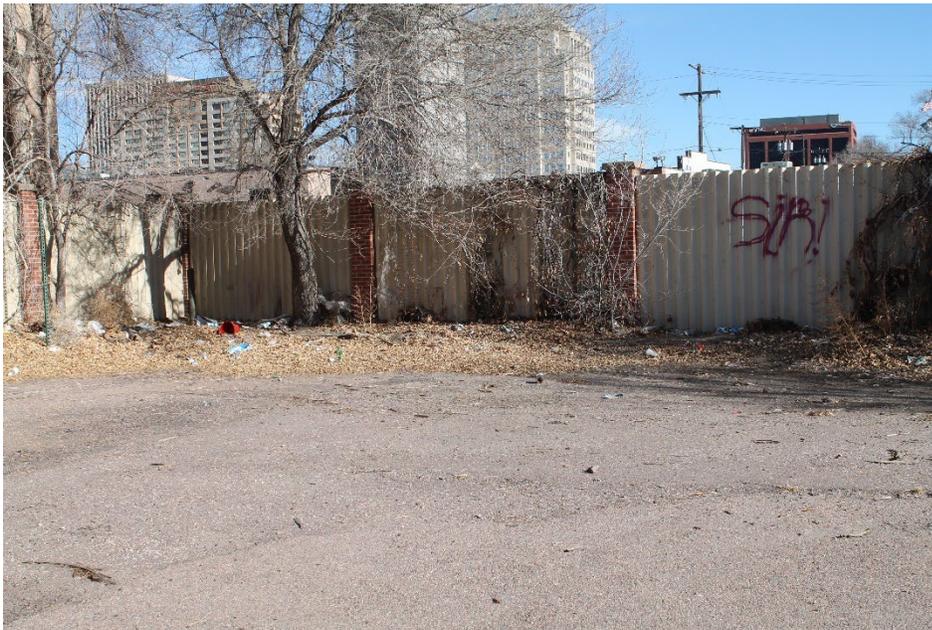
**Figure 2-8 Deteriorated walls/fences, deteriorated parking areas, poor parking lot layout, insufficient/deteriorated drainage, cracked or uneven pedestrian surfaces, unsafe level changes, deteriorated curb and gutter, trash and debris, inadequate site maintenance, non-conformance to development regulations, vagrants/graffiti/vandalism (Photo B-13)**

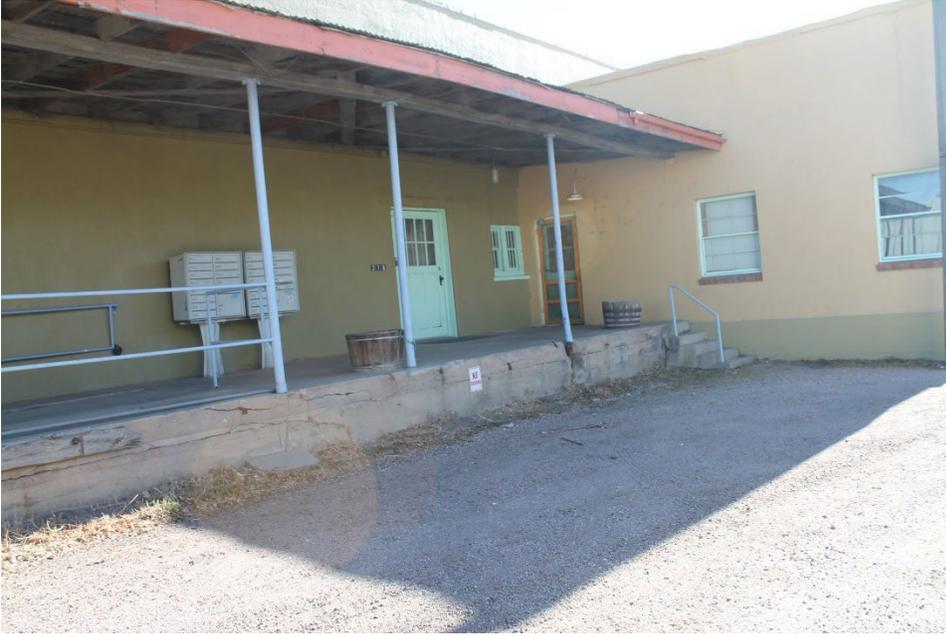
**Figure 2-9 Deteriorated visible foundation, deteriorated gutter/downspouts, potentially hazardous conditions, unsafe level changes (Photo B-19)**

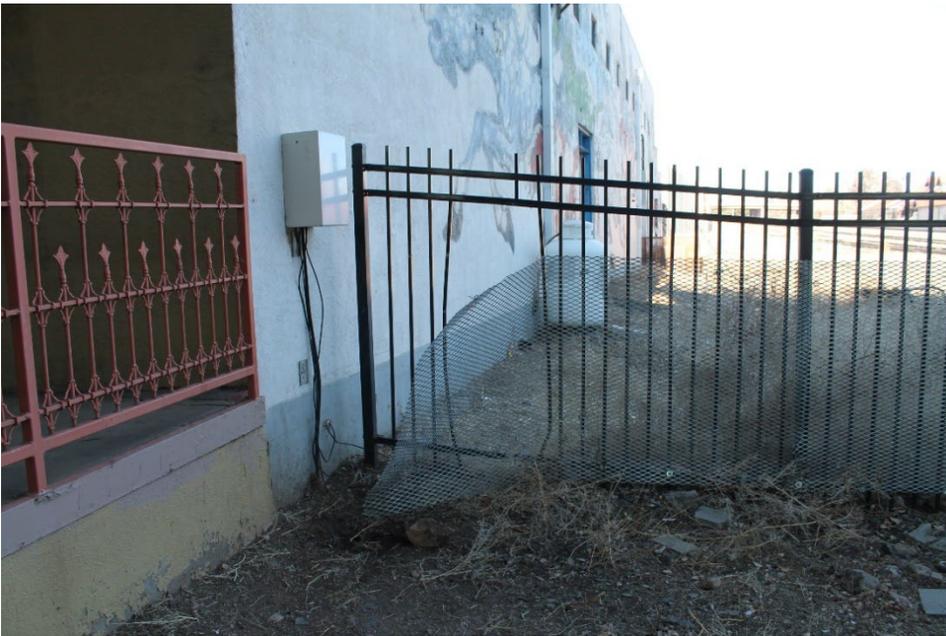
**Figure 2-10 Presence of trash and debris, inadequate site maintenance, deteriorated fences, vagrants/graffiti/vandalism (Photo D-10)**
