CityGate Site
Conditions Survey

City of Colorado Springs, Colorado

August 2006

Colorado Springs Urban Renewal Authority
Colorado Springs, Colorado City Council

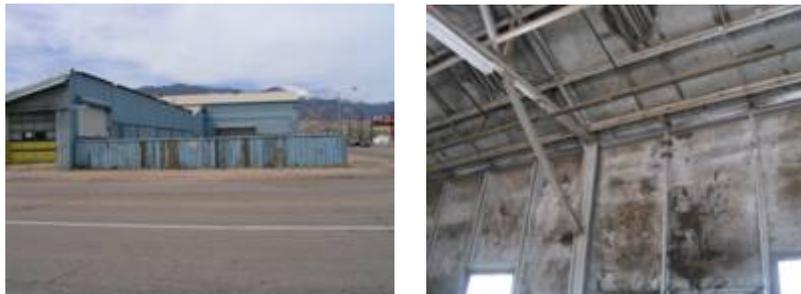
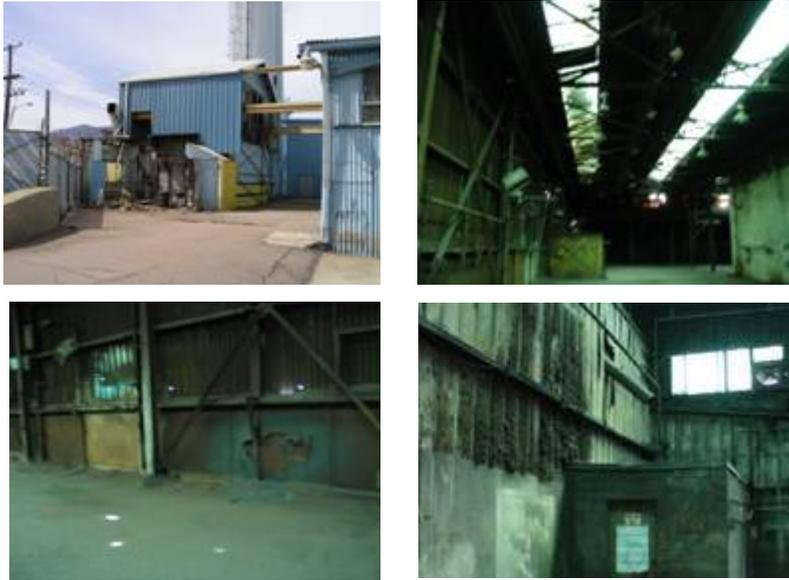
Deterioration and deteriorating structures could be found in all but the southeast quadrant of the Area. The worst conditions were found in the northeast quadrant, within the foundry and fabrication areas, although many outbuildings and other improvements in the northwest and southwest areas suffer from deterioration as well, as do most of the fences on the property. Examples of properties affected by Condition (a) are shown in the photos in Exhibit 2 below.

Exhibit 2: Examples of Condition A (Deteriorating Structures)

Exhibit 2 (cont.): Examples of Condition A (Deteriorating Structures)

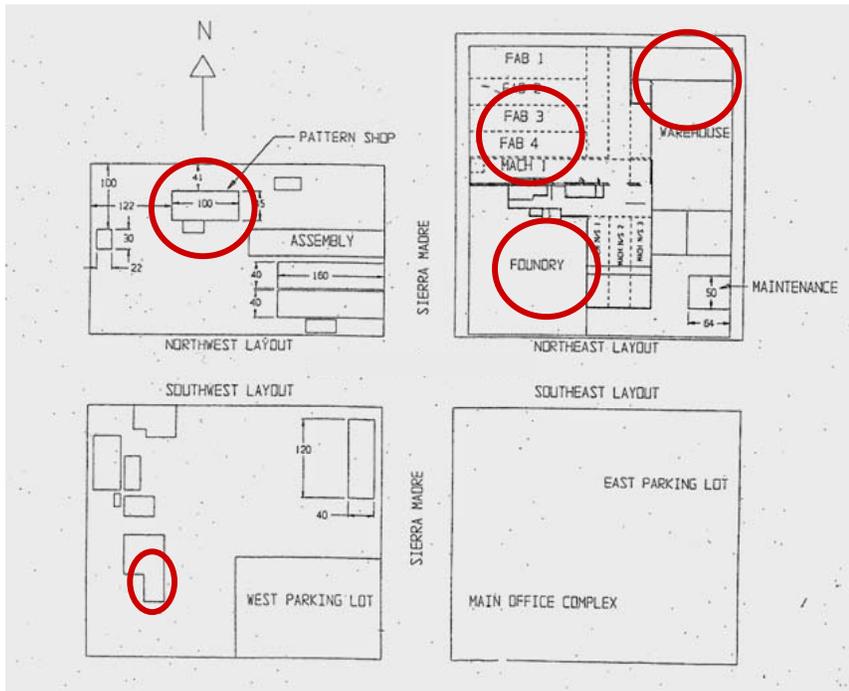
Exhibit 3 (cont.): General Location of Worst Instances of Condition A

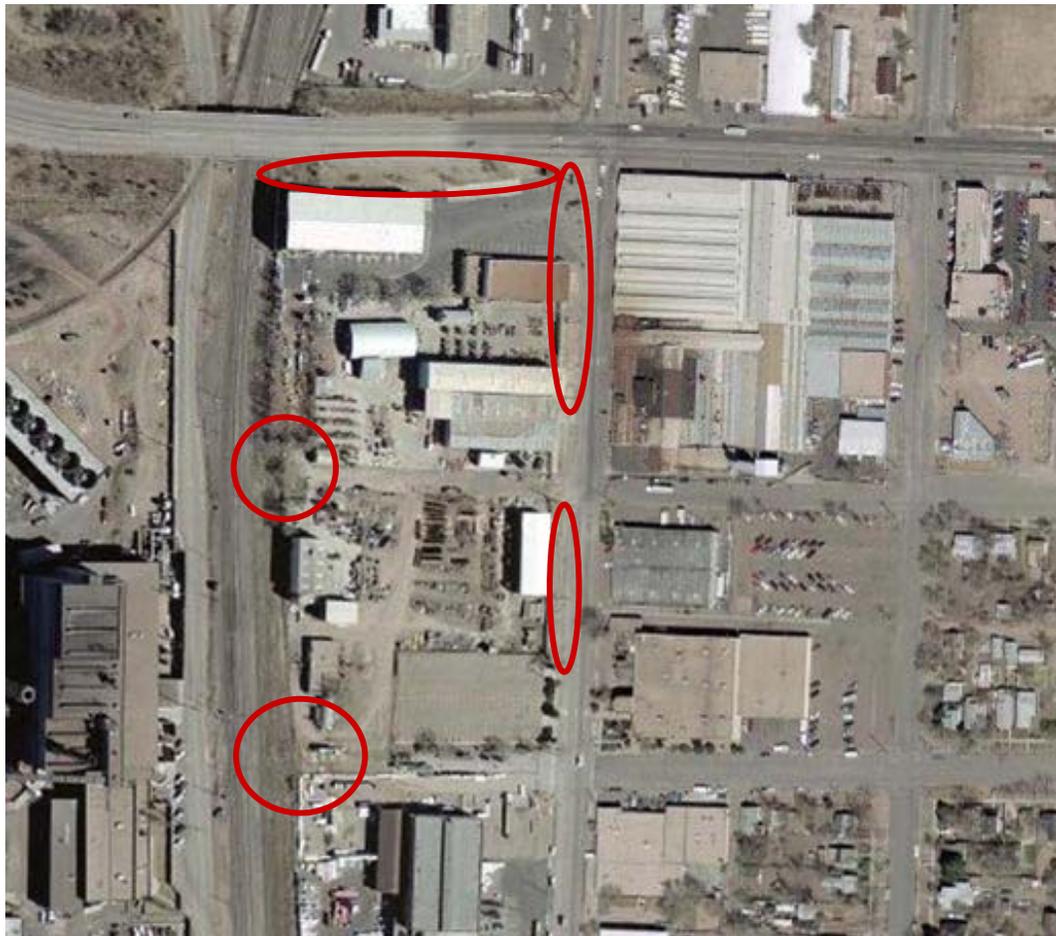
Issues impacting street layout include the interruption of east-west vehicular flow at Moreno Avenue and Rio Grande Street, due to the presence of railroad tracks. Street layout is also compromised along Sahwath Street, Cimarron Street and Sierra Madre Streets due to substandard and missing curb cuts leading into the Metso property in several locations.

Exhibit 4: Primary Locations of Condition B (Faulty or Inadequate Street Layout)

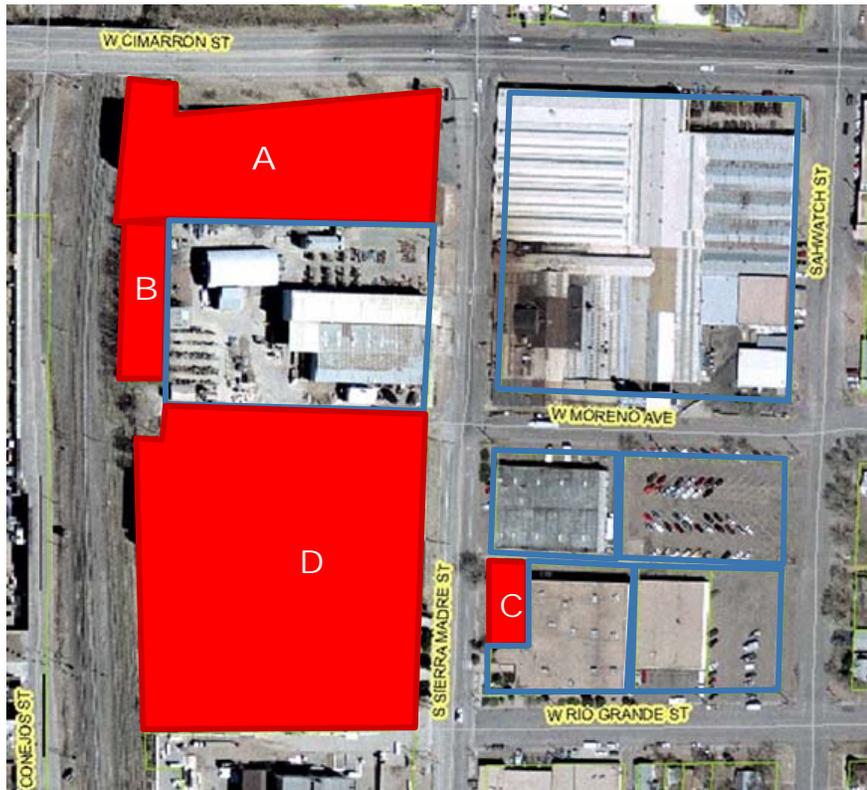
Parcels smaller than one-half acre are considered by many municipalities to be of inadequate size because of significant constraints on the range of (re-) development options available to this lot size particularly given setback, parking, and other regulatory requirements. Three parcels in the Area are less than one-half acre in size. The parcels noted as Lots B and C in Exhibit 5 below are the smallest of these.

Lot layout is also deemed to be faulty if the configuration relative to the street is contrary to what allows for development. Lot shape is considered faulty if the shape is unusual to the extent that it deters or constrains (re-) development options. At least two parcels in the Area have faulty layouts relative to the street – labeled as Lots A and B in Exhibit 5.

Poor access, a condition related to poor lot layout, is discussed in the subsection above under *Defective or Inadequate Street Layout*, and is also indicative of faulty lot layout. The presence of railroad tracks along the western boundary of the Area is detrimental to vehicular access particularly for Lots B and D, shown in Exhibit 5.

Exhibit 5: Examples of Condition C: Faulty/Inadequate Lot Layout

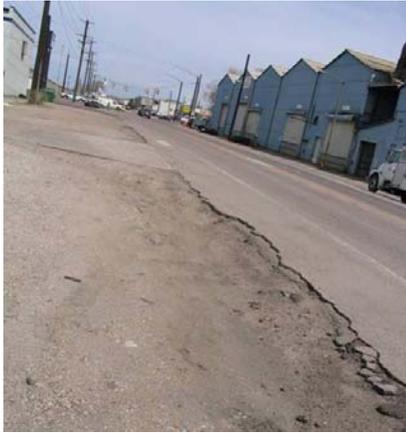
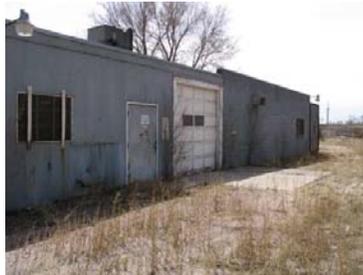
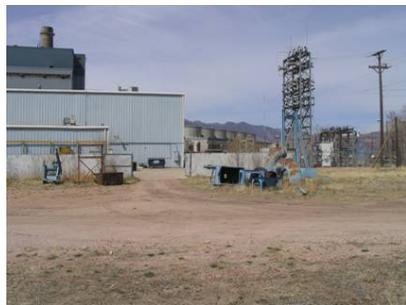
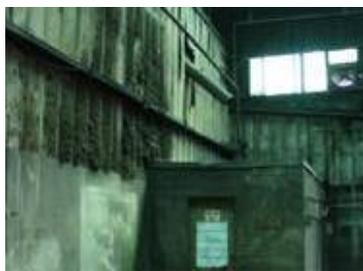
Unsafe or unsanitary conditions can be found throughout the Survey Area, primarily concentrated around the vacant foundry and related facilities. Much of the open fields on the southwest and northwest properties are covered with litter and weeds. The foundry and some of the fabrication and storage buildings have become home to pigeons, vermin and wild animals. Their presence, along with the significant accumulations of bird and animal waste, pose a potential health hazard for those facilities. The majority of outdoor spaces on the property are poorly lit or (more commonly) not lighted at all. Unscreened scrap metal and mechanical equipment can be found in numerous locations throughout the Area. Surrounding sidewalks (where present) suffer from frequent, significant cracks and unsafe deterioration.

Exhibit 6: Examples of Condition D: Unsafe or Unsanitary Conditions

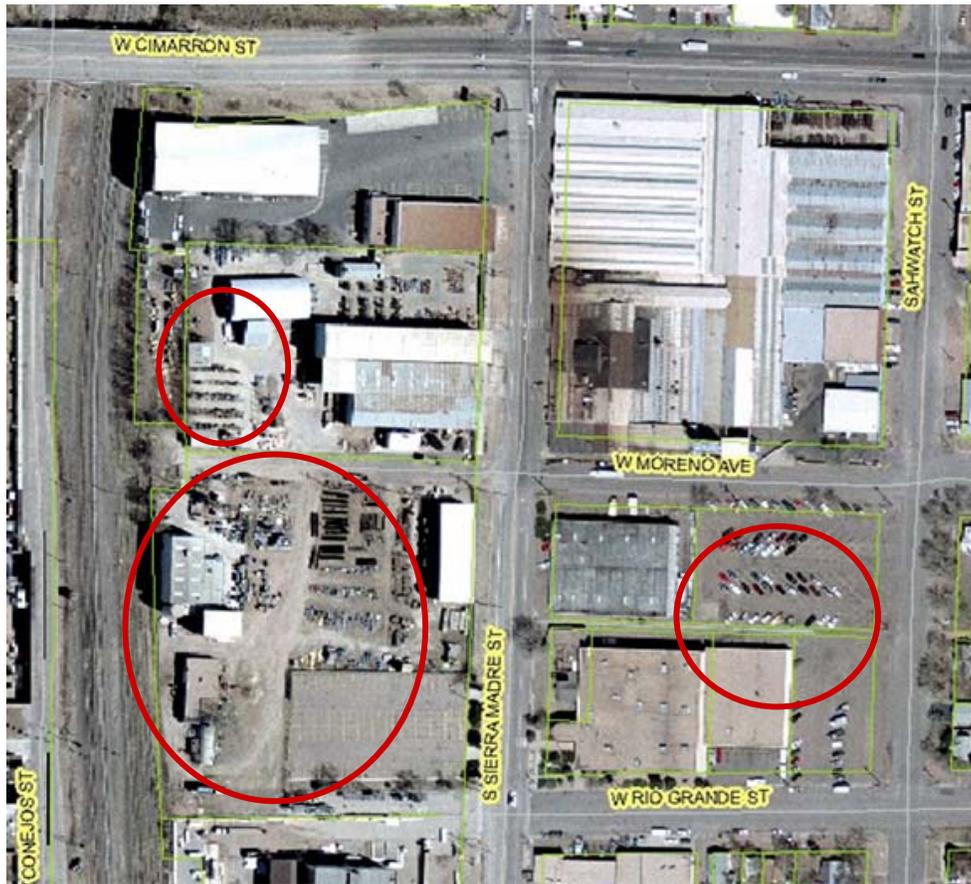
Exhibit 7: Primary Locations of Condition D: Unsafe or Unsanitary Conditions

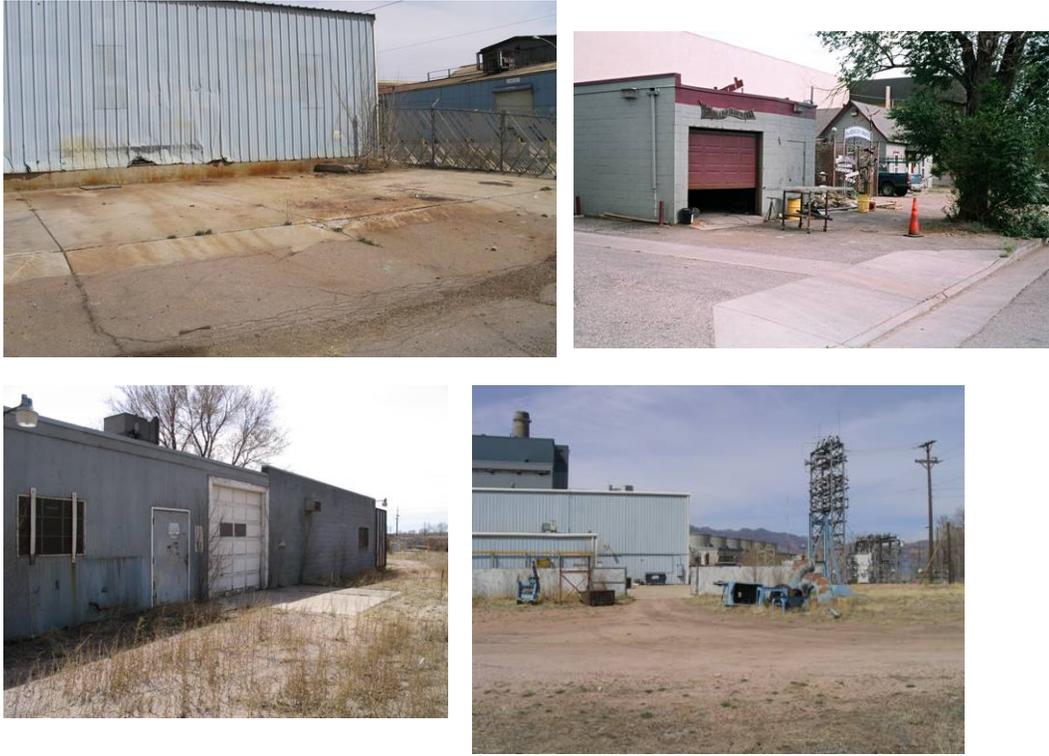
A variety of blight conditions were observed within the Area related to deterioration of the site and non-primary improvements. As expected with a largely abandoned facility, the grounds, outbuildings, and open areas were observed to be in a relatively neglected state, with litter, weeds, deteriorating fencing, and often badly damaged paved surfaces. The main office complex, in the southeast quadrant of the Survey Area, is generally free of these problems.

Exhibit 8: Examples of Condition E: Deterioration of Site or Other Improvements

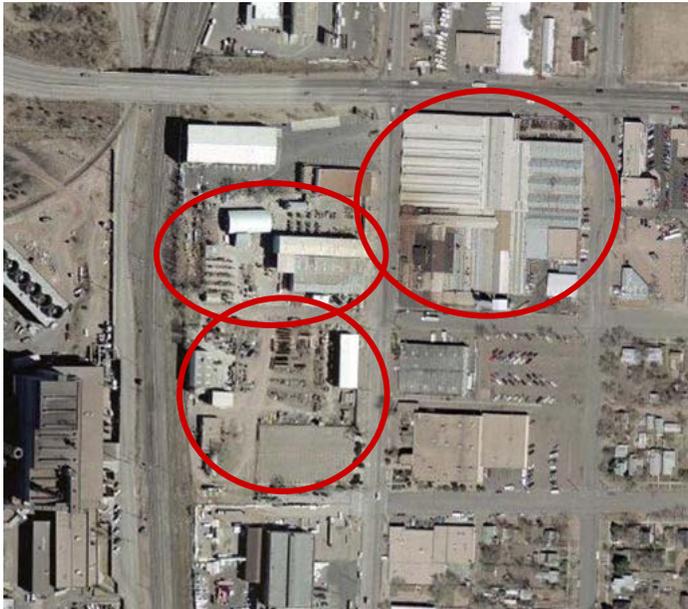
Exhibit 9: Primary Location of Condition E: Deterioration of Site or Other Improvements

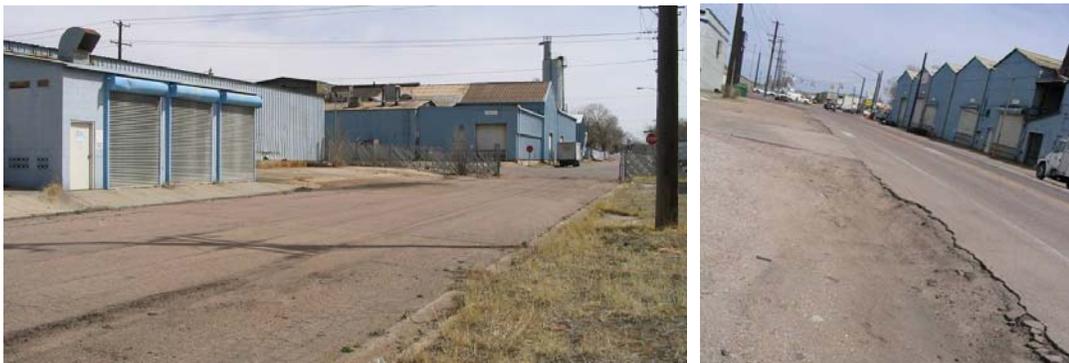
Provision of electric utilities on at least part of the property is unusual, with a separate substation not connected to the city grid. This poses a barrier to redevelopment and, as such, is considered an inadequate public improvement for the purposes of this analysis. Other public improvements such as sidewalks, street lighting, street pavement maintenance, curb & gutter, and storm drainage are lacking throughout the subject property. Again, many of these public improvements are present and in better condition in the vicinity of the main office complex in the southeast quadrant of the Area.

Exhibit 10: Condition F (Inadequate Public Improvements)

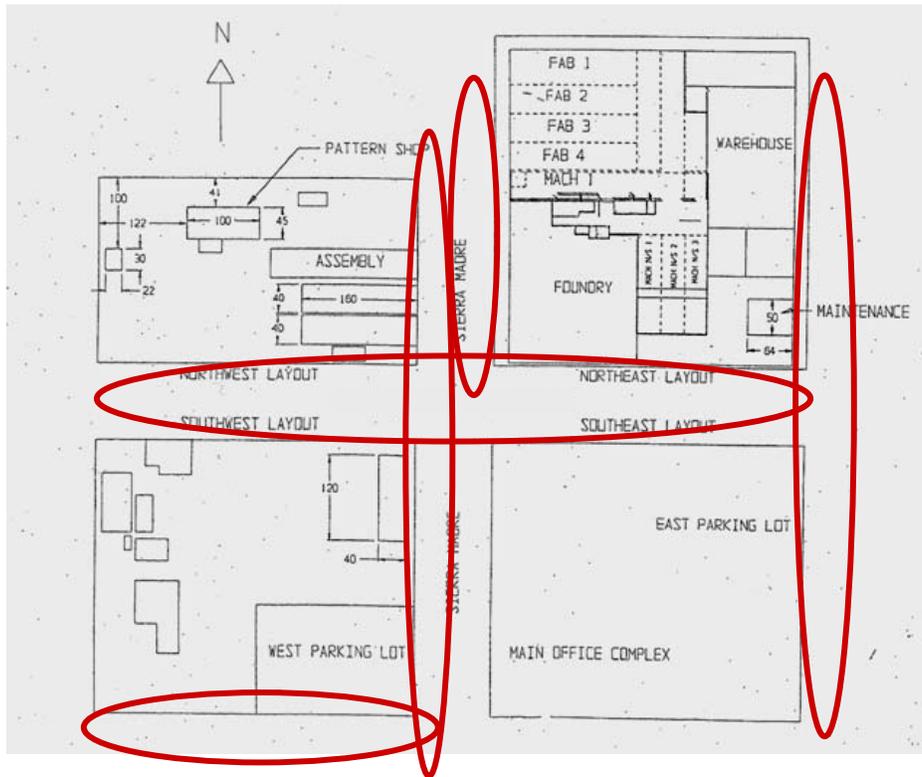
Exhibit 11: General Locations of Condition F (Inadequate Public Improvements)

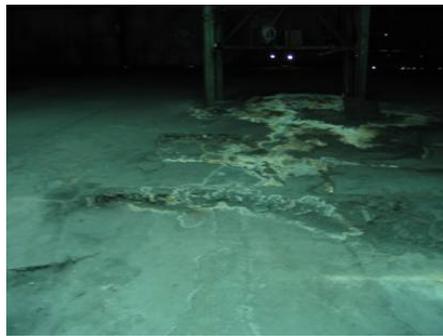
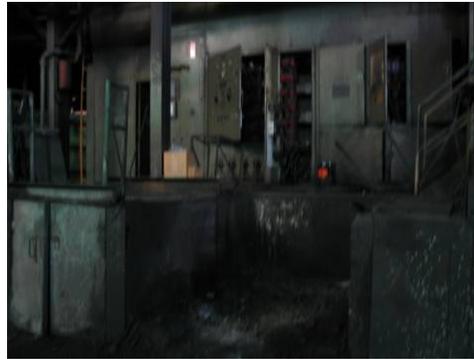
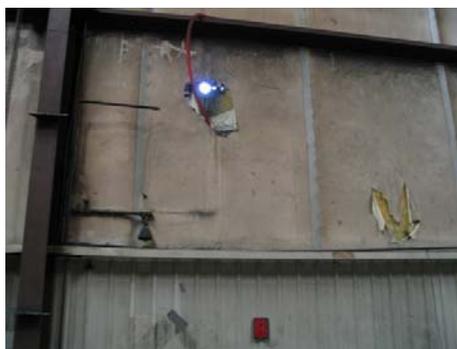
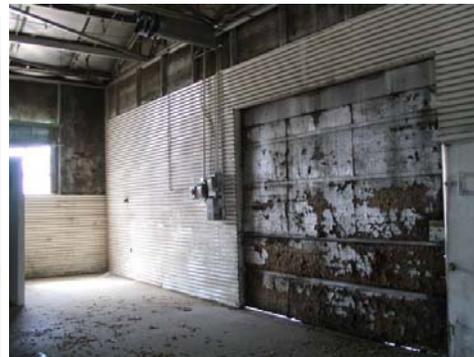
Unhealthy or unsafe building conditions are present on parcels with structures that have obviously unsafe structures or facilities. In their current state of neglect and disrepair, several of the buildings on the property could be considered unsafe for working – particularly the foundry and adjacent fabrication space. Torn or otherwise damaged walls and ceilings, open high voltage areas, apparent chemical spillage, and evidence of inside vermin (pigeons, foxes, etc.) all contribute to apparent safety hazards in these structures. Again, the southeast quadrant is notably free of such problems. While the northwest and southwest quadrants have maintenance problems, it is unclear whether they would be unsafe for working per the statute

Exhibit 12: Condition I (Buildings or Facilities Unsafe for Living or Working)

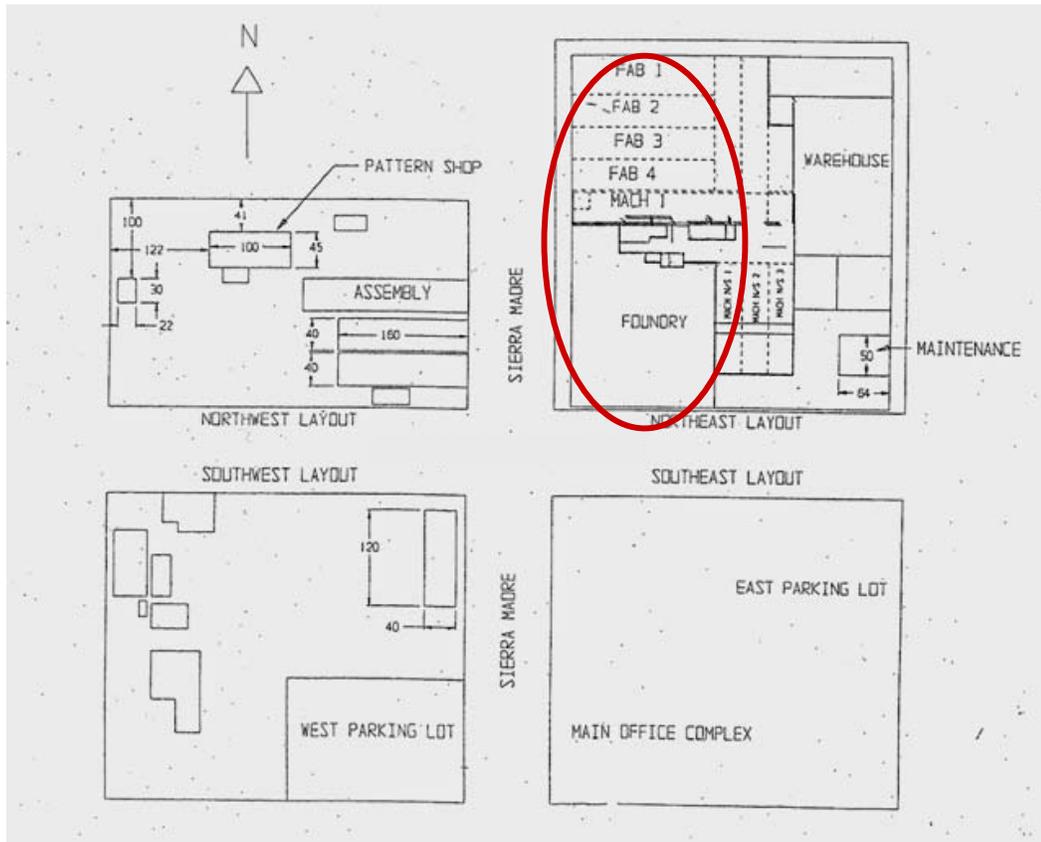
Exhibit 13: General Location of Condition I (Buildings or Facilities Unsafe for Living or Working)

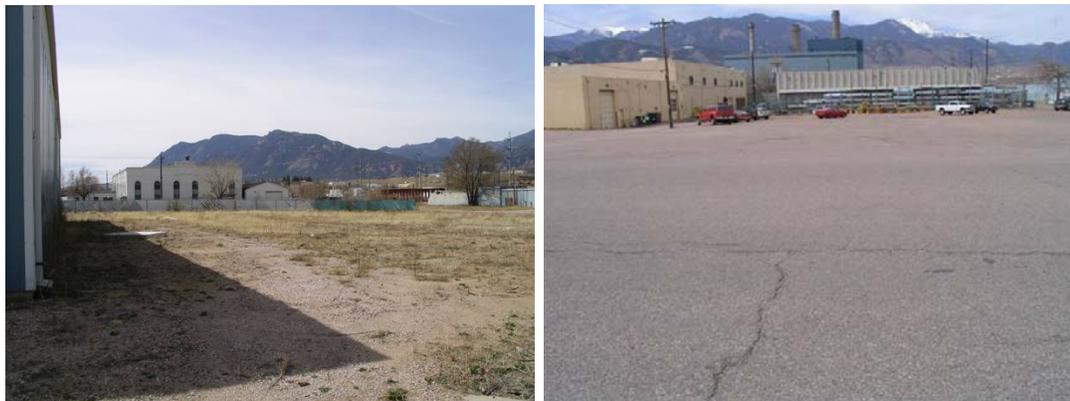
Areas characterized by “substantial physical underutilization or vacancy of sites, buildings, or other improvements” include vacant lots, parcels with vacant structures, or parcels for which the value of its improvement is disproportionately small relative to the land value. The site is clearly under-utilized per the state blight statute, as evidenced by vacancies in each of the quadrants. With the exception of the far northeast quadrant, the southeast quadrant and lab portion of the southwest quadrant, the Survey Area is entirely vacant. The east parking lot (in the southeast quadrant) can also be considered underutilized, because it serves only a small number of employees relative to its capacity.

Exhibit 14: Examples of Condition K.5 (Site Underutilization)

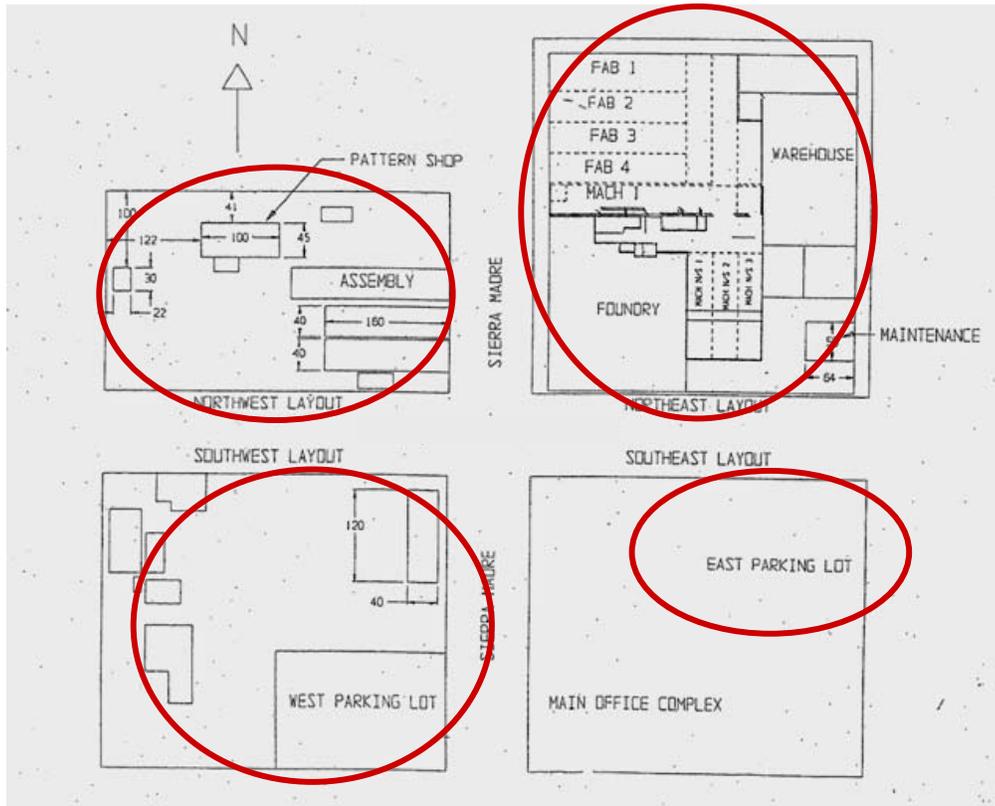
Exhibit 15: General Locations of Condition K.5 (Site Underutilization)
