Draft Report

Lowell-Draper Existing Conditions Survey

City of Colorado Springs Urban Renewal Authority

Economic & Planning Systems, Inc.

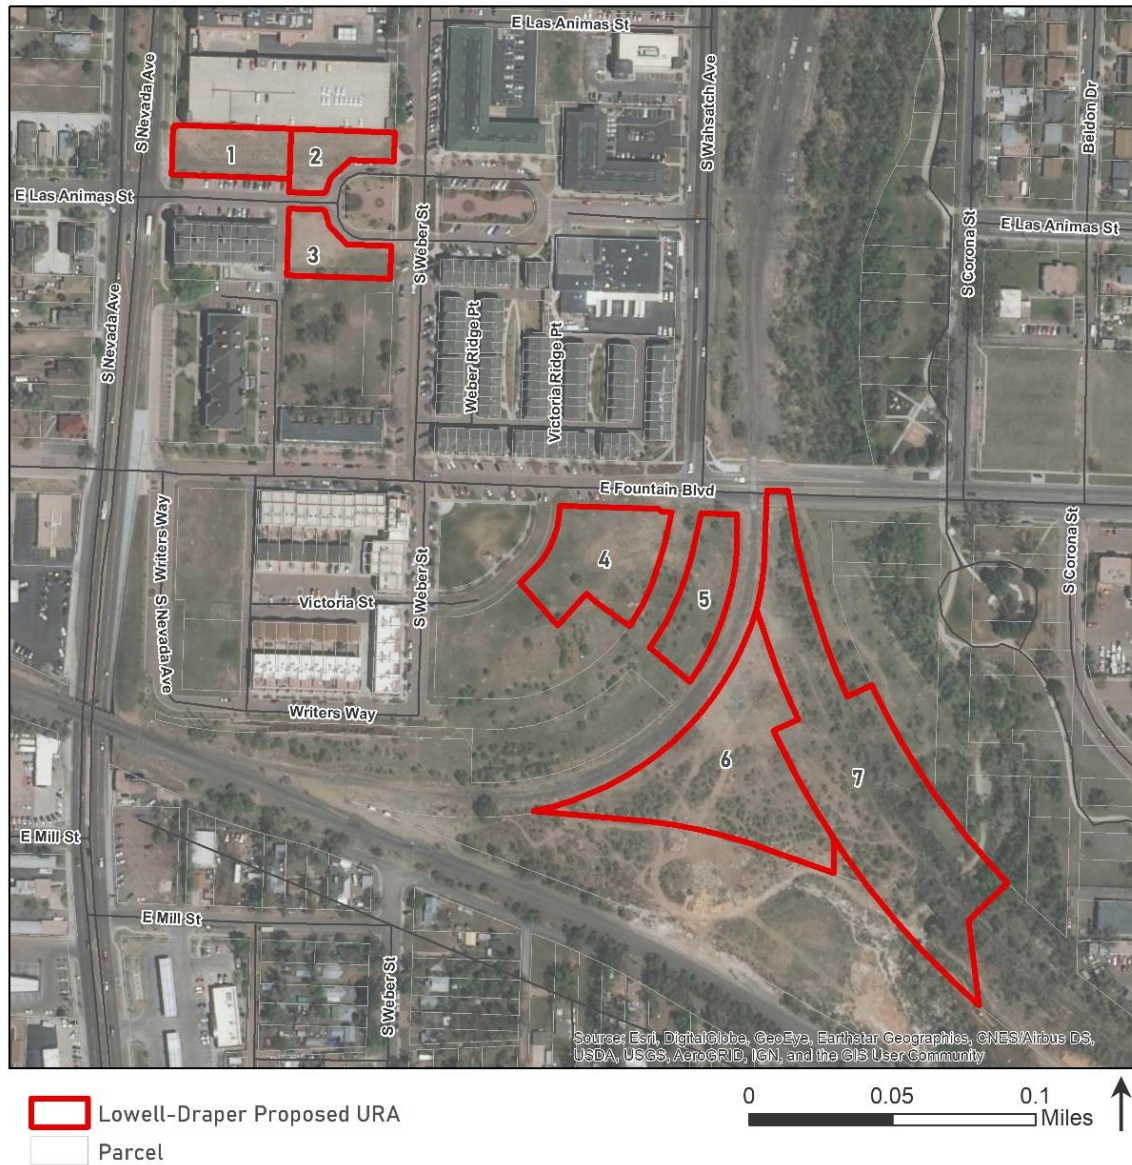
Figure 1. Lowell-Draper Proposed URA Boundary and Parcels

The proposed Lowell-Draper Urban Renewal Plan Area is comprised of seven parcels on approximately 7.26 acres of land, as shown in **Table 1** and **Figure 1**. All parcels are owned by Qof Lowell Commons LLC. Parcels 1 to 3 are located along East Las Animas Street with South Weber Street to the east and South Nevada Avenue to the west. Parcels 4 to 7 are located south of East Fountain Boulevard with South Corona Street to the east and South Weber Street to the west. All seven parcels are vacant and have no building improvements.

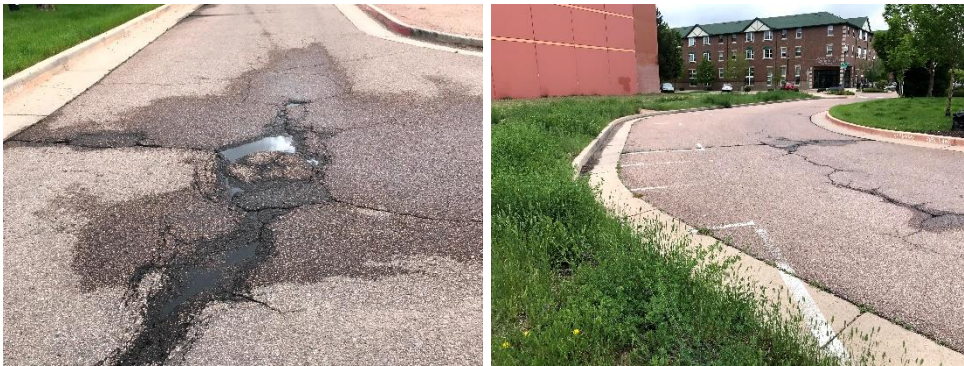
Figure 2. Poor Provision of Street Improvements

Along East Las Animas Street near parcels 1, 2, and 3 of the Study Area, poor provisions of the streets for vehicular traffic were observed in the form of large potholes and deteriorating pavement, shown in **Figure 2**. Throughout this portion of the Study Area, provisions of walkways for pedestrians were observed in the form of lack of sidewalks. In particular, parcel 3 has curb cuts but no paved sidewalk, shown in **Figure 3**. Additionally, there are no sidewalk or pedestrian improvements along parcels 4, 5, or 6 to connect to the existing pedestrian network on adjacent properties.

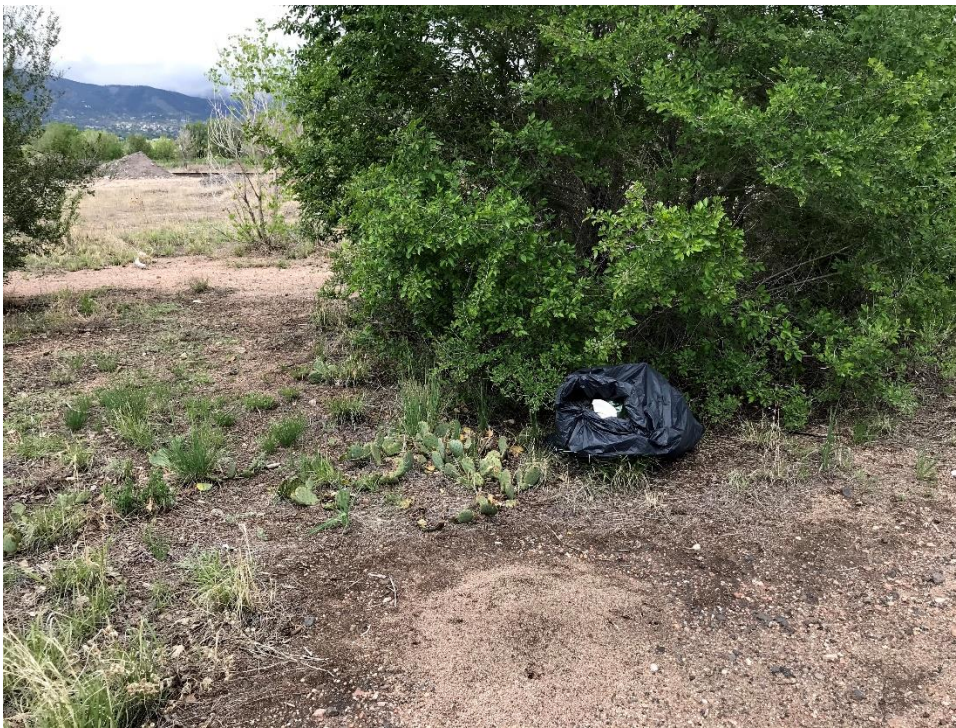
Figure 4. Illegal Dumping

Throughout the Study Area unsafe and unsanitary conditions were documented, including illegal dumping, litter, and evidence of vagrants. Illegal dumping was observed southeast of the railroad tracks, shown in **Figure 4**. Excessive litter was observed and documented throughout the properties and was especially apparent along East Fountain Boulevard, shown in **Figure 5**. There was evidence of vagrants on the property with a makeshift sleeping area shown in **Figure 6**. Additionally, using Google Earth imagery there were excessive homeless encampments throughout parcels 6 and 7, shown in **Figure 7**.

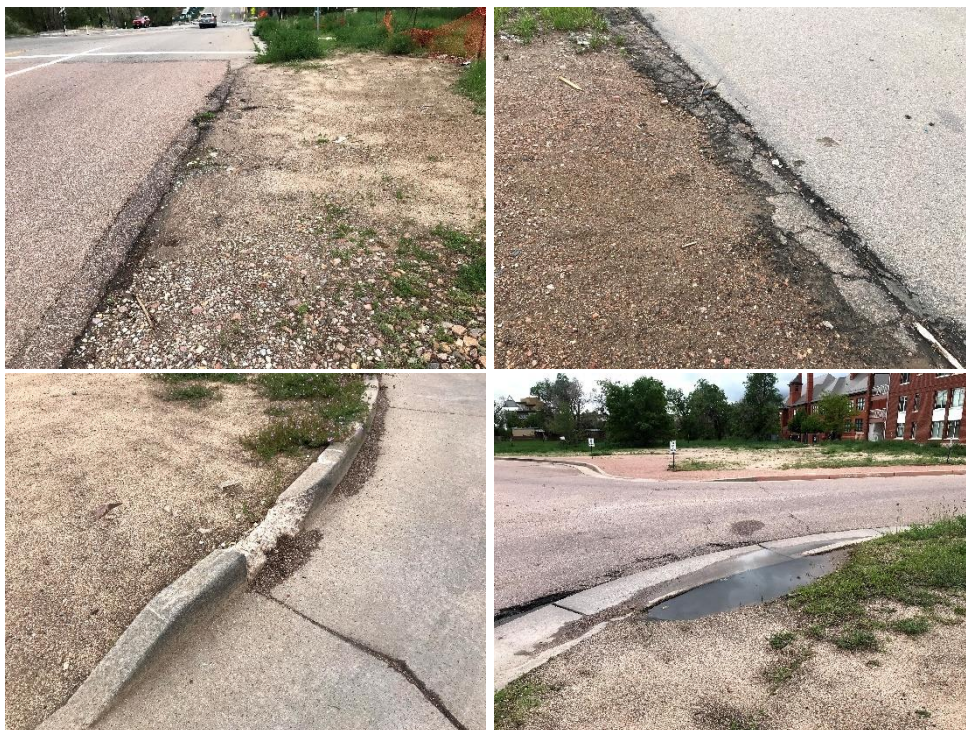
Figure 8. Deteriorated Curbs

There are very minimal site improvements on the properties. Of the improvements in place, deterioration of curbs was most apparent. This was observed for the parcels along East Fountain Boulevard as well as parcels along East Las Animas Street in the Study Area, shown in **Figure 8**. Overall, there was evidence that the properties have been neglected with little maintenance.

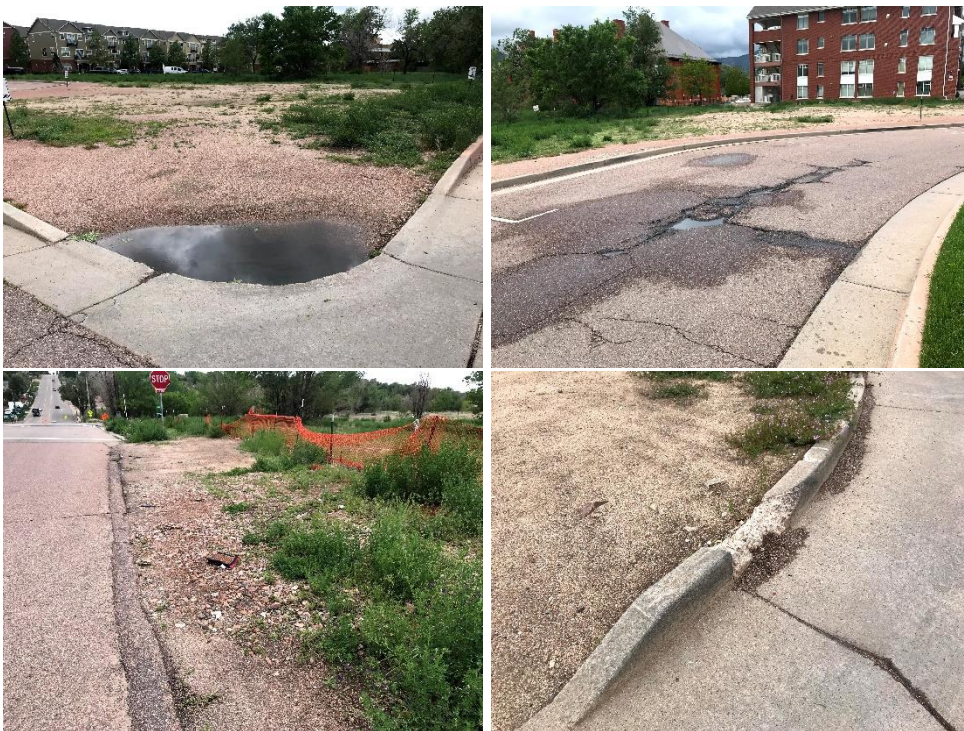
Figure 9. Deteriorated Pavement and Curbs and Missing Sidewalks

Inadequate infrastructure was observed throughout the Study Area, predominately in the form of deteriorated pavement, deterioritated or missing curbs, and missing sidewalks, shown in **Figure 9**. Additionally, unusual topography was observed in parcels 6 and 7 in the form of steep slopes, shown in **Figure 10**.

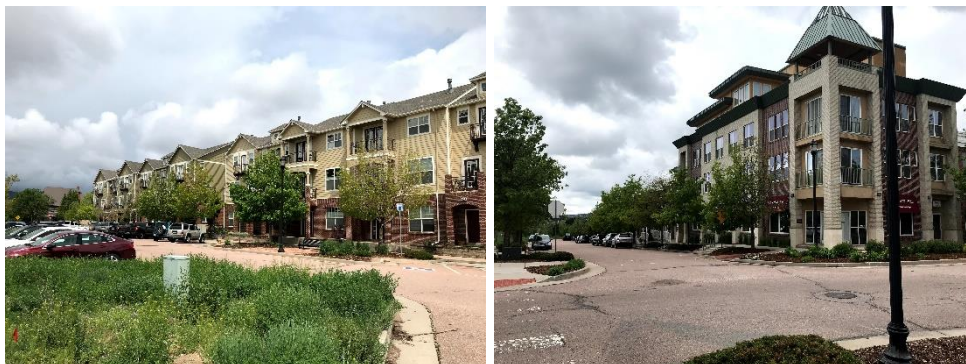
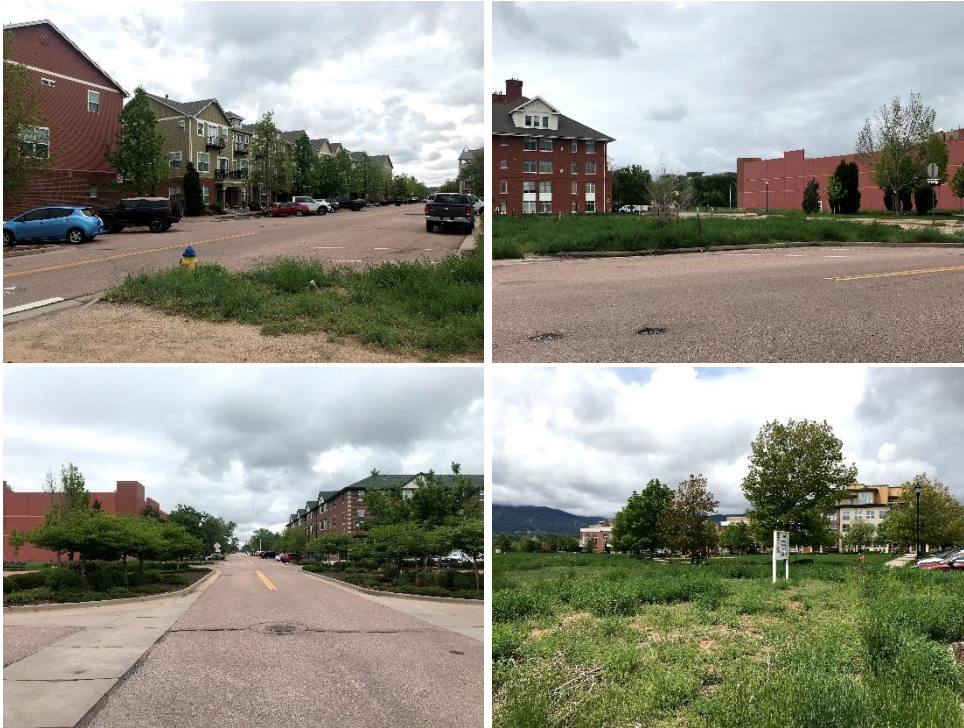
Figure 11. Vacant Property in Generally Urbanized Area

The entire 7.26-acre Study Area is vacant with no building improvements. The properties are surrounded by development, shown in **Figure 11**, with townhomes and a park along East Fountain Road and South Weber Street, Colorado Springs Police Department north of parcels 1 and 2, and various commercial properties and Shooks Run Trail east of parcel 7. Additionally, railroad tracks run through the Study Area between parcels 5, 6, and 7. There are multiple planned and proposed infill developments on parcels near the Study Area that will be market rate housing. This area southeast of downtown is very urban and the Study Area are one of the few remaining properties undeveloped.
