## Draft Report

# O'Neil Existing Conditions Survey

City of Colorado Springs Urban Renewal Authority

August 19, 2022

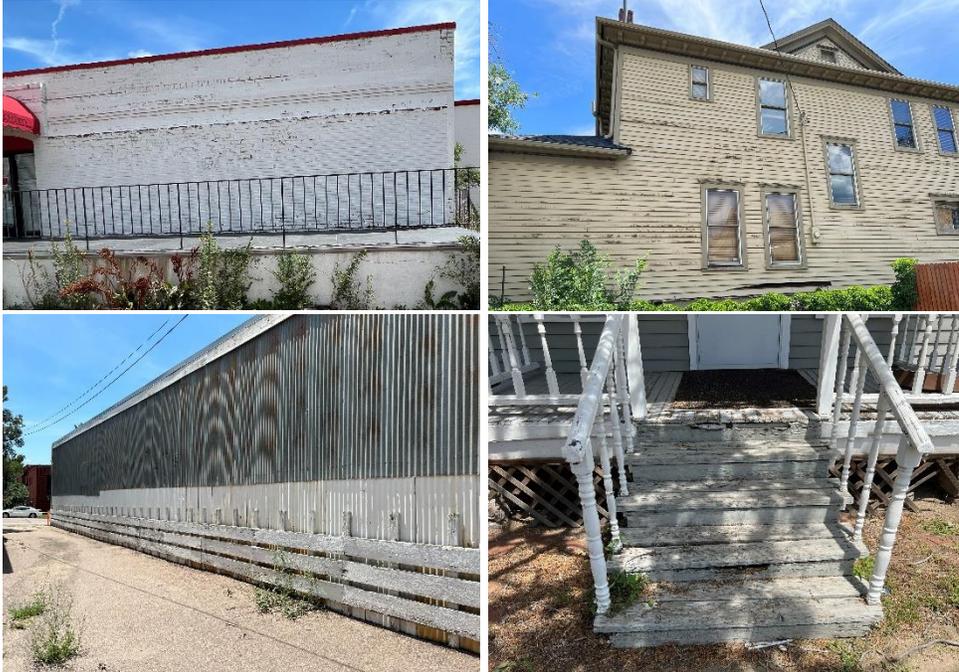
**Figure 2. Deteriorated Exterior Finishes and Stairways**

Multiple buildings in the Study Area have deteriorated exterior finishes with chipped paint, exposed brick, and rusted and worn-out metal siding, shown in **Figure 2**. The single family home on Parcel 3 has a deteriorated wooden stairway to the front porch as well as chipped paint.

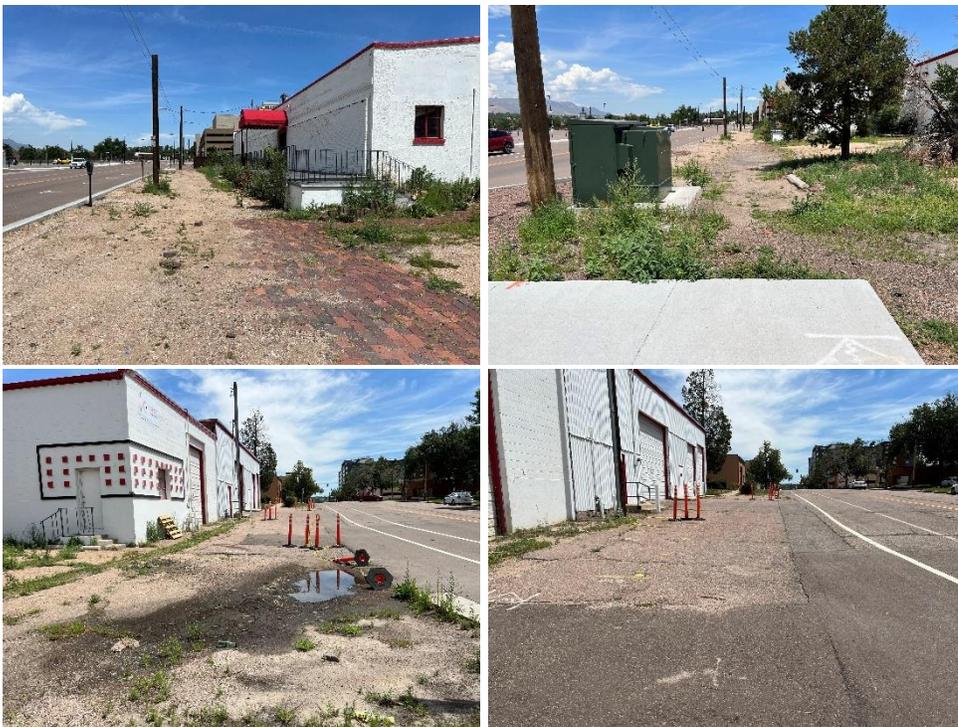
**Figure 3. Poor Provision of Street Improvements for Pedestrians**

Poor provisions of street improvements for pedestrians were observed in the form of lack of sidewalks along Sahwatch Street on parcel 1 and along Costilla Street on parcels 1 and 2, as shown in **Figure 3**. Along Sahwatch Street there is a defined curb but no sidewalk and along Costilla Street there is dirt and a large driveway for commercial vehicles. It is important to note at the corner of Sahwatch and Costilla Street pedestrian improvements were made with curb cuts and a small portion of sidewalk. These are extensions of the sidewalk improvements on the opposite sides of the streets and illustrates the disconnect the Study Area has within the existing pedestrian network.

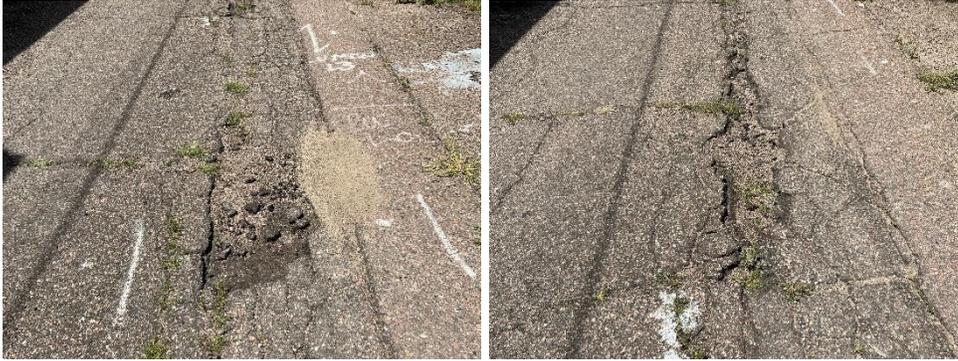
**Figure 4. Poor Provision of Street Improvements for Vehicles**

Additionally, poor provisions of street improvements for vehicles were observed in the form of potholes and cracked pavement in the alley on the northside of the Study Area, shown below in **Figure 4**.

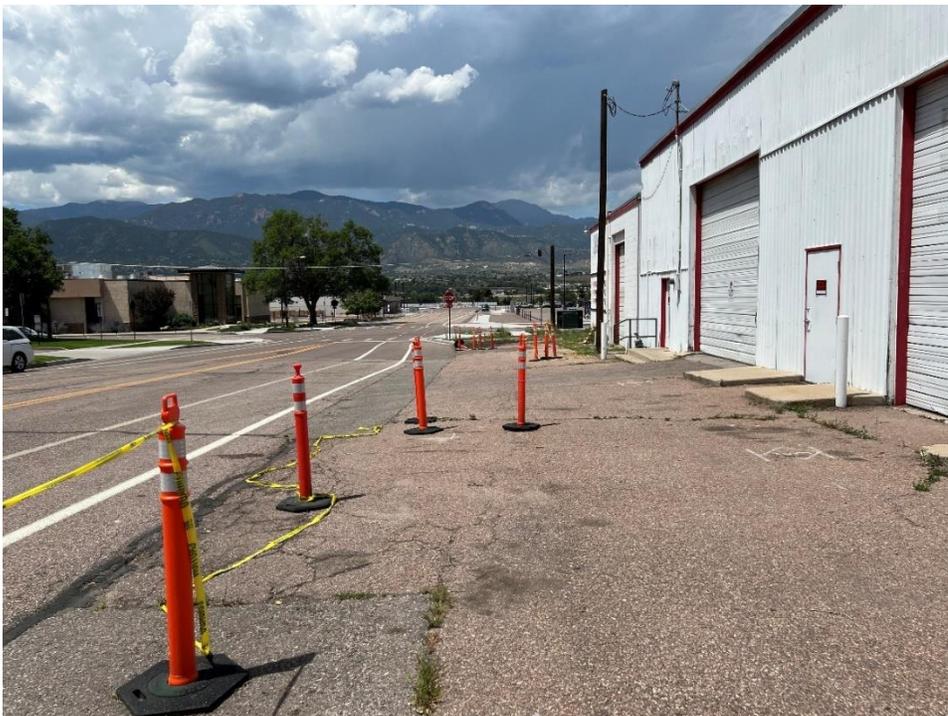
**Figure 5. Excessive Curb Cuts Along Commercial Blocks**

There is an excessive driveway along Costilla Street for the existing warehouse/storage facilities on parcels 1 and 2, shown in **Figure 5**. The drive covers approximately a third of the block and does not include curb cuts or a sidewalk.

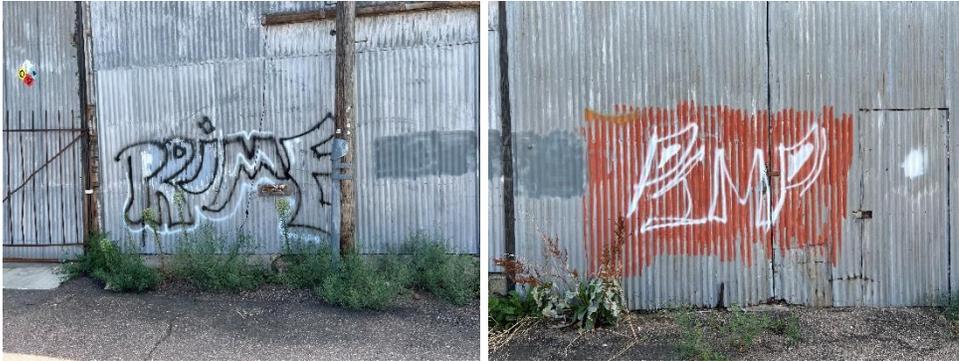
**Figure 6. Vandalism/Graffiti**

Throughout the Study Area unsafe and unsanitary conditions were documented, including vandalism/graffiti, excessive litter, and evidence of vagrants. Vandalism/graffiti was observed in alley on the backside of the building on parcel 2, shown in **Figure 6**.

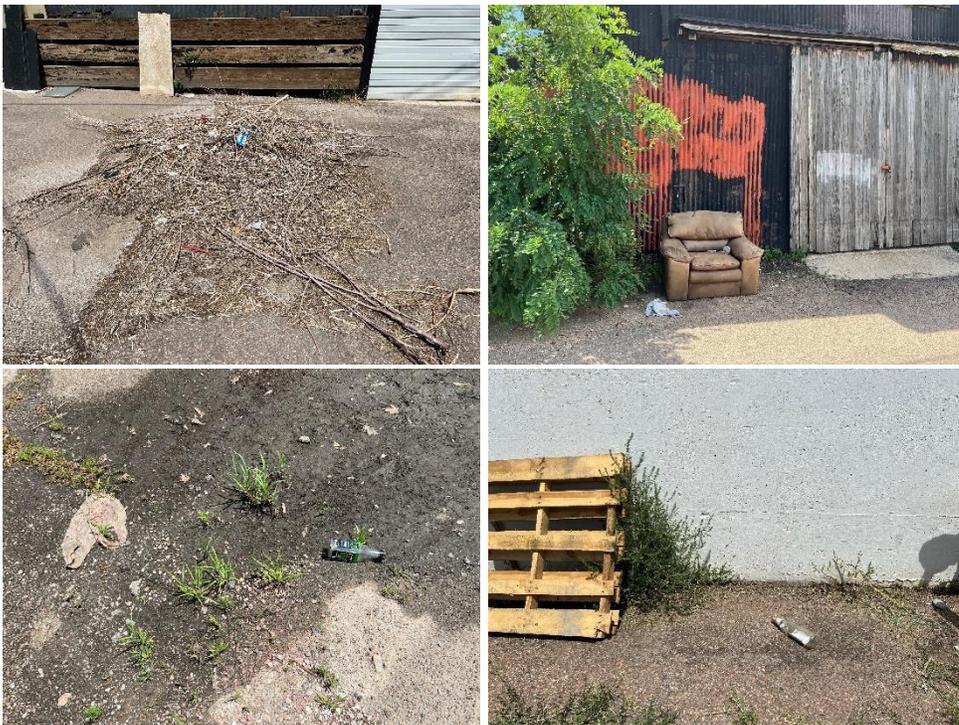
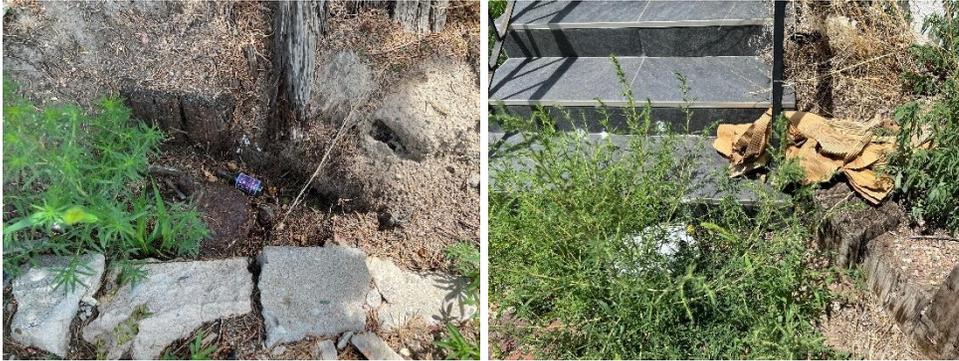
**Figure 7. Excessive Litter**

Excessive litter was observed and documented throughout the Study Area, shown in **Figure 7**.

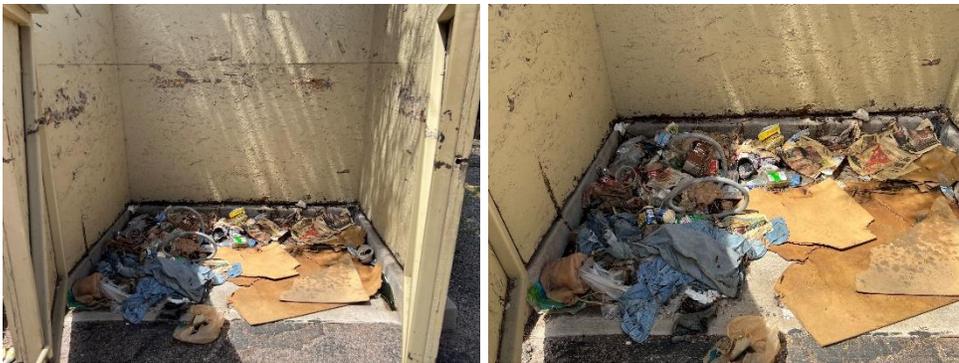
**Figure 8. Evidence of Vagrants**

Evidence of vagrant(s) was observed on parcel 4 in the gated area for the dumpster. The dumpster was removed and there was evidence that a person had been sleeping and hanging out there, shown in **Figure 8**.

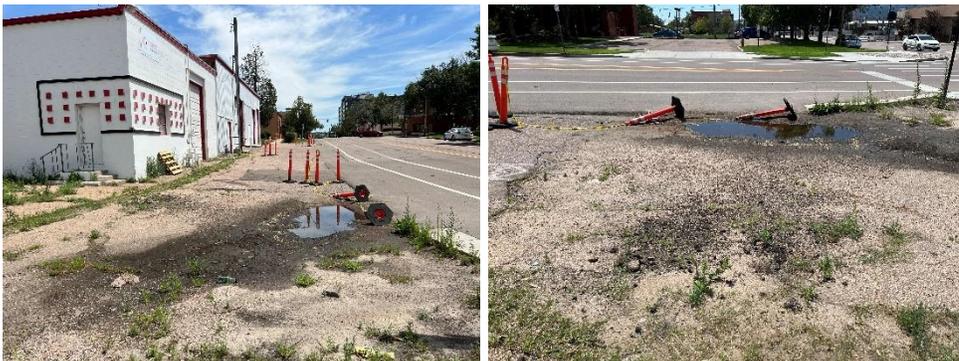
**Figure 9. Evidence of Standing Water**

Additionally, standing water was observed on parcel 1 along Costilla Street, shown below in **Figure 9**, which may indicate inadequate stormwater drainage.

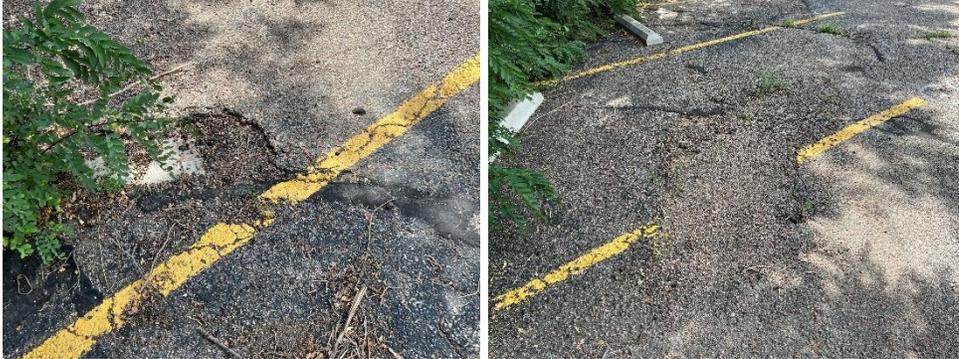
**Figure 10. Deteriorated On-Site Parking Surfaces**

Deterioration of site improvements were observed throughout the Study Area and overall the site shows signs of neglect. The small parking lot on parcel 4 showed signs of deterioration with missing sections of pavement and pot holes, shown in **Figure 10**.

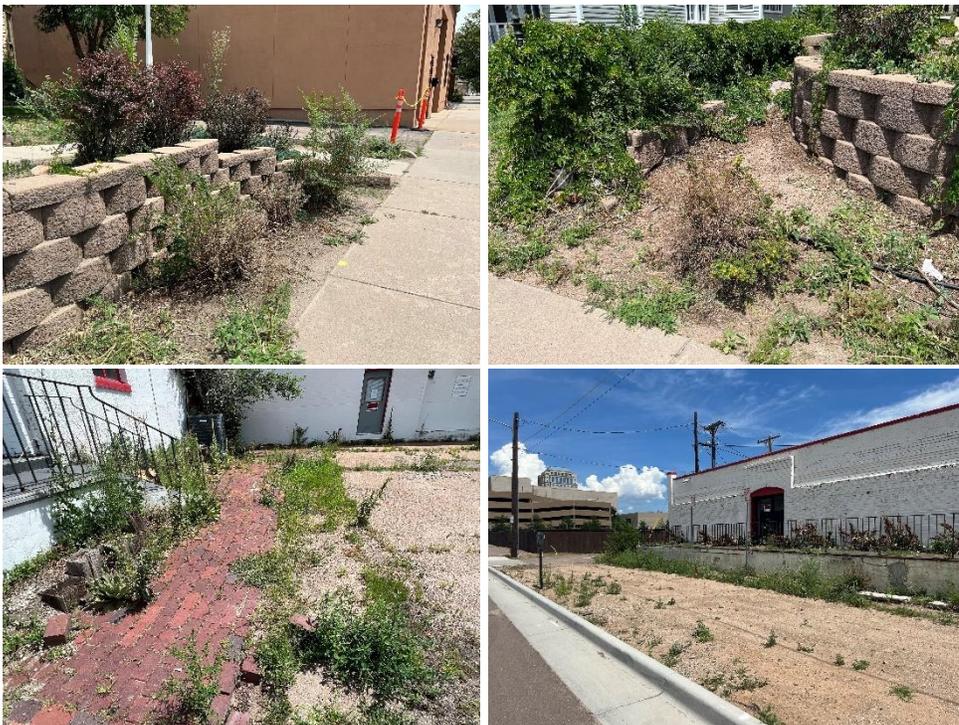
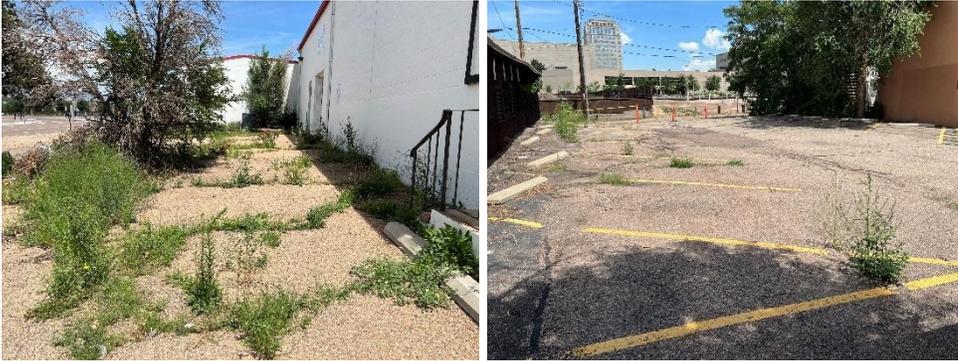
**Figure 11. Overgrown Vegetation**

Overgrown vegetation and poorly maintained landscaping was observed throughout the Study Area, shown in **Figure 11**.

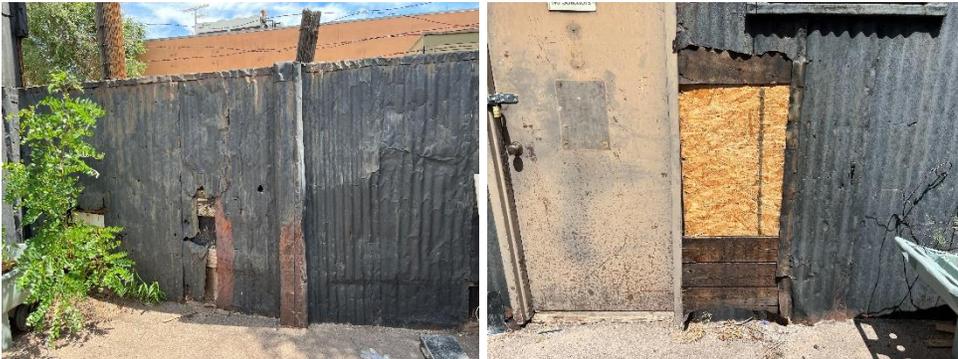
**Figure 12. Deteriorated Fences and Walls**

On parcel 3 a deteriorated portion of fence and exterior wall of the shed was observed, shown below in **Figure 12**.

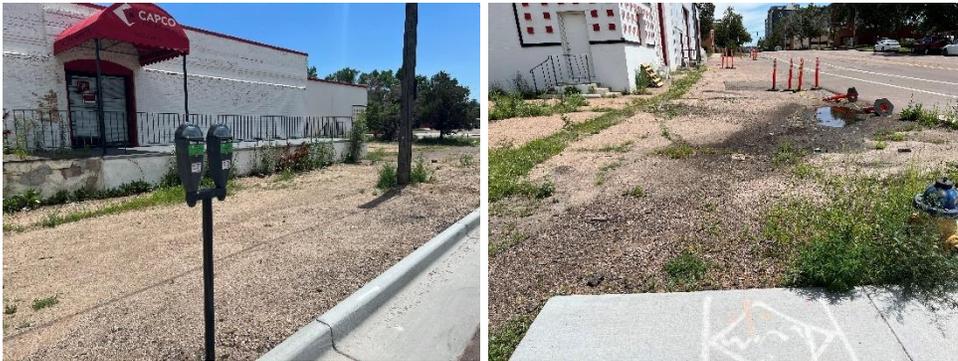
**Figure 13. Lack of Sidewalks and Curb**

Inadequate infrastructure was observed throughout the Study Area, predominately in the form of deteriorated pavement and lack of curbs and sidewalks. As previously mentioned, there is no sidewalk along Sahwatch Street and Costilla Street on parcels 1 and 2, shown in **Figure 13**.

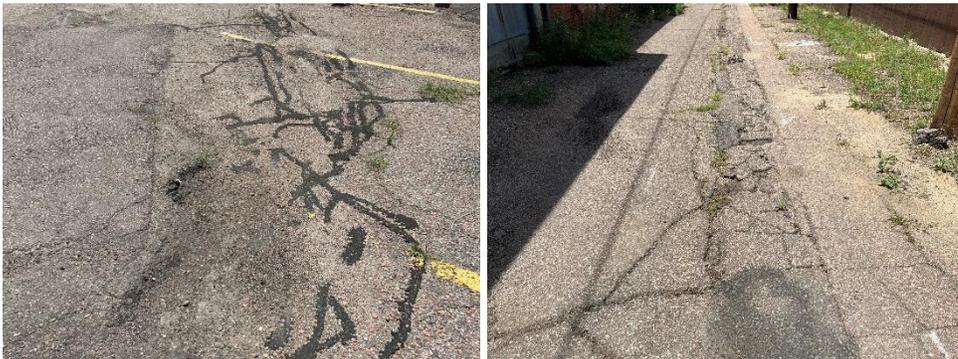
**Figure 14. Deteriorated Pavement**

In addition, the section along Costilla Street is also missing a curb. Deteriorated pavement was observed on the parking lot on parcel 4 and along the alley behind all the parcels, as shown in **Figure 14**.

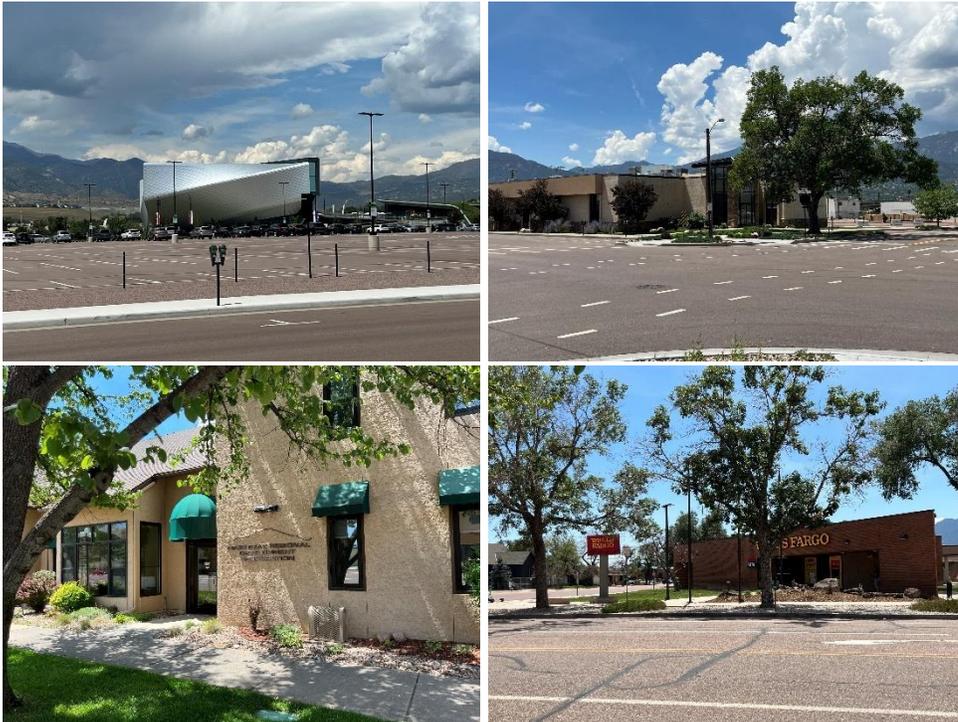
**Figure 15. Underdeveloped Parcels in an Urbanized Area**

The Study Area is comprised of parcels that are underdeveloped and underutilized in the urban location. The surrounding context of the Study Area is largely developed with commercial uses, shown in **Figure 15**, with the U.S. Olympic and Paralympic Muesum to the west, Colorado Springs Conservatory and Wells Fargo Bank to the south, Pikes Peak Regional Development Corporation to the east, and government buildings on the block to the north. The Study Area is in Downtown Colorado Springs and currently underutilized with older industrial uses and single family residences, all of which are currently vacant.
