**Conditions Study for  
Southwest Downtown Study Area  
Colorado Springs, Colorado**

Colorado Springs Urban Renewal Authority (CSURA)  
30 South Nevada Avenue, Suite 502  
Colorado Springs CO 80903

**DGC** Community Planning and Design

March 2016

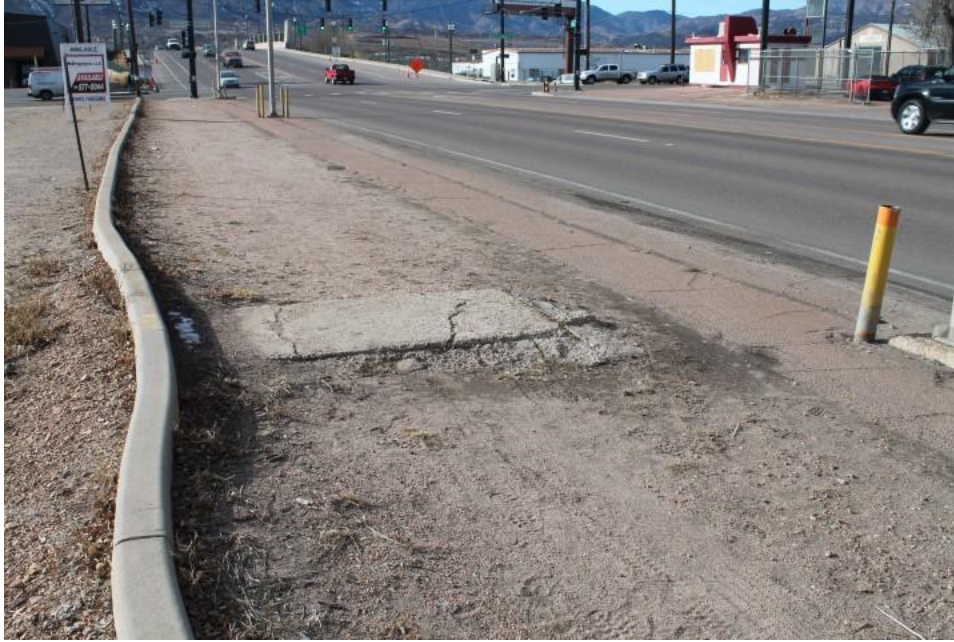
**Figure 2-2 Substandard driveway/curb cuts, cracked or uneven pedestrian surfaces, unsafe level changes, deteriorated curb and gutter, inadequate and deteriorated sidewalk, non-conformance to development regulations (Photo A-3)**

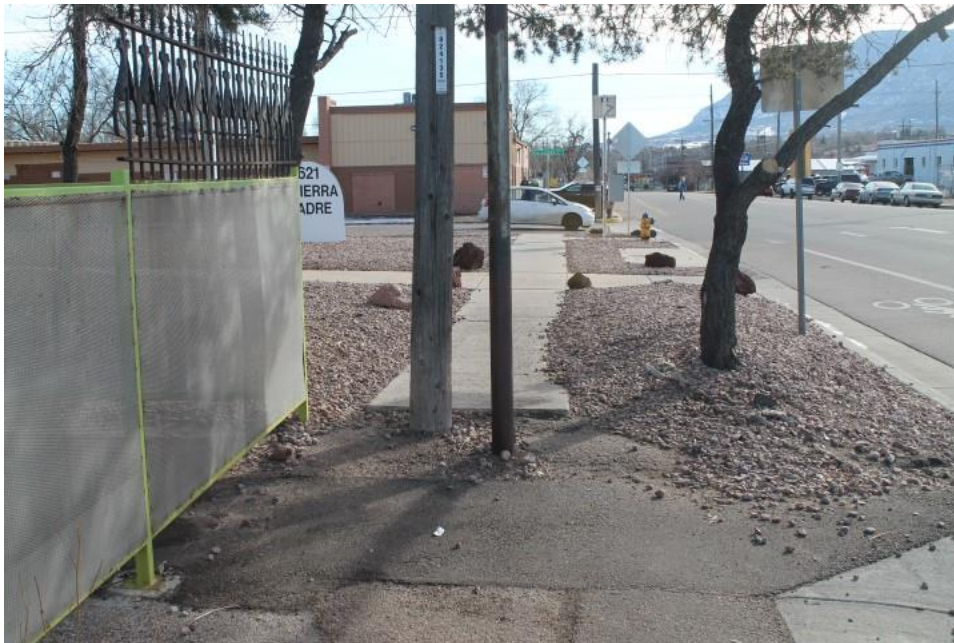
**Figure 2-3 Substandard driveway/curb cuts, cracked or uneven pedestrian surfaces, unsafe level changes, deteriorated curb and gutter, inadequate and deteriorated sidewalk, non-conformance to development regulations (Photo A-9)**

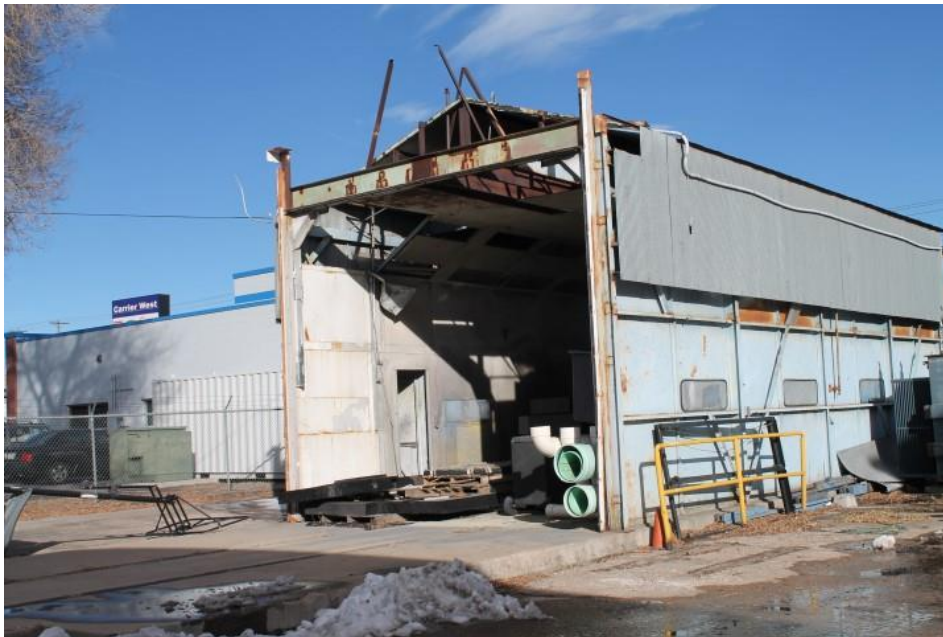
**Figure 2-4 Multiple examples of deteriorated building exterior and structure, potentially hazardous conditions, unsafe level changes, building code violations, dilapidated building interior, unprotected electrical systems, inadequate fire suppression systems (Photo A-17)**

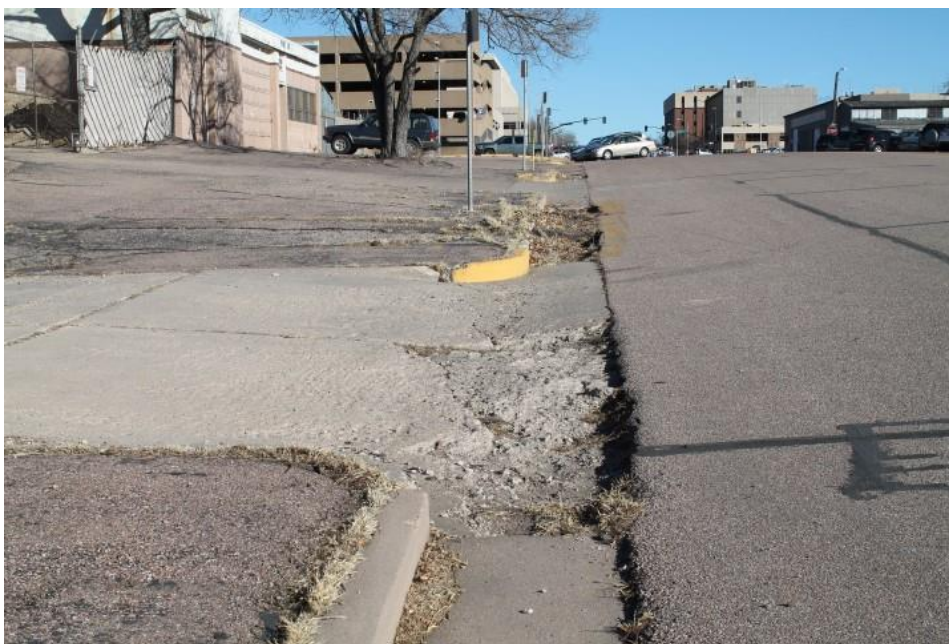
**Figure 2-5 Presence of trash and debris, substandard driveway/curb cuts, cracked and uneven surfaces, unsafe level changes, deteriorated curb and gutter, inadequate and deteriorated sidewalk, inadequate site maintenance, non-conformance to development regulations (Photo B-11)**

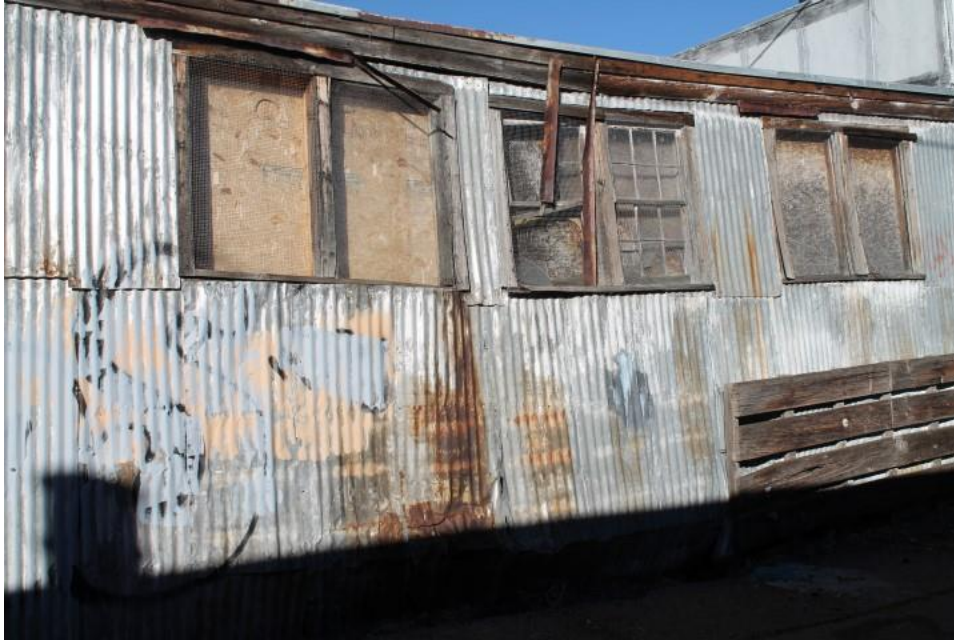
**Figure 2-6 Multiple examples of deteriorated building exterior and structure, vagrants/vandalism/graffiti, building code violations (Photo B-16)**

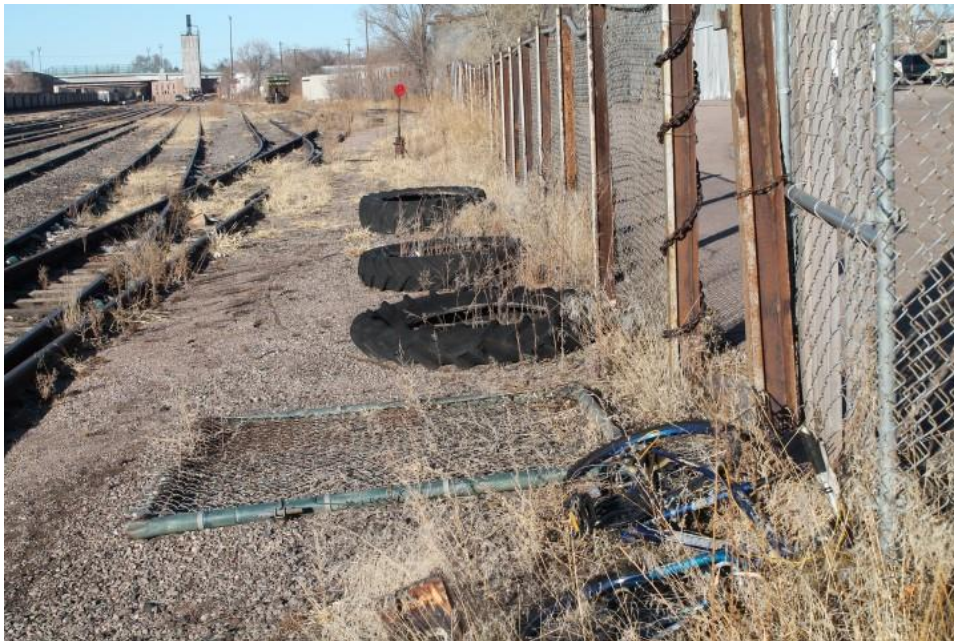
**Figure 2-7 Presence of trash and debris, abandoned/inoperable equipment, potentially hazardous conditions, vagrants/vandalism/graffiti, inadequate site maintenance, non-conformance to development regulations (Photo B-29)**

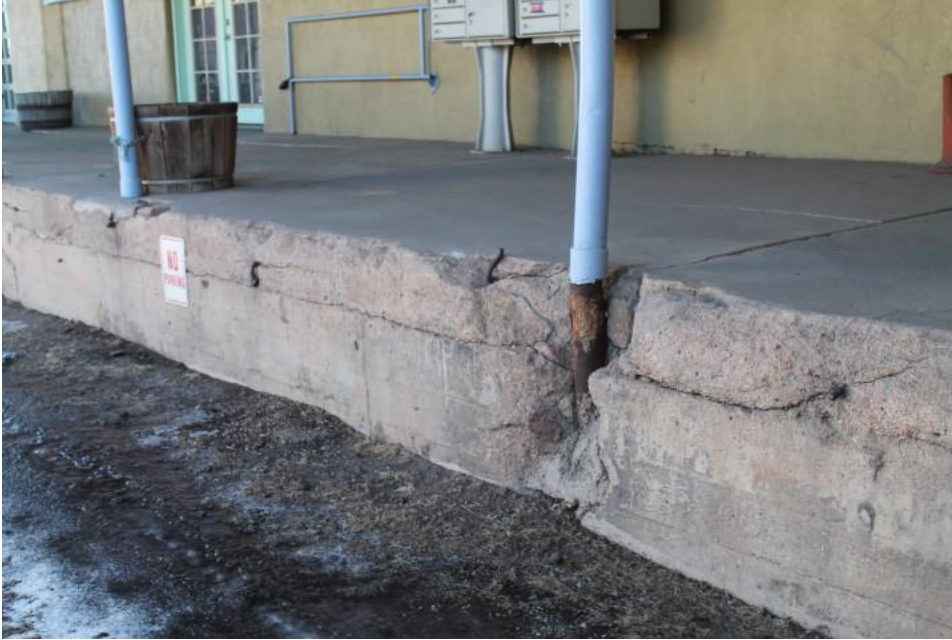
**Figure 2-8 Deteriorated visible foundation, deteriorated gutter/downspouts, potentially hazardous conditions, unsafe level changes (Photo C-2)**

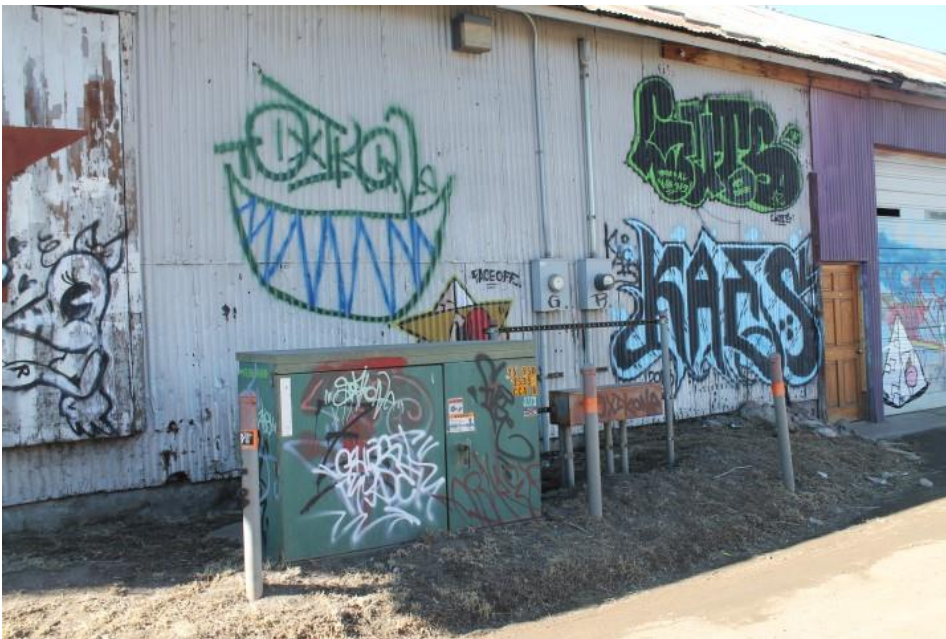
**Figure 2-9 Deteriorated exterior walls, deteriorated fascia/eaves, lack of gutters/downspouts, vagrants/graffiti/vandalism (Photo C-3)**

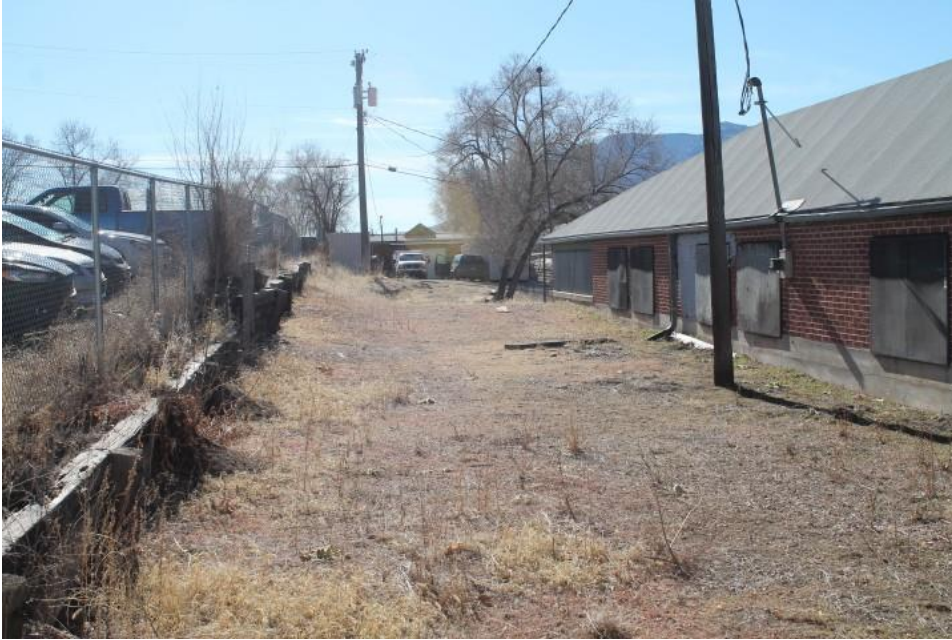
**Figure 2-10 Presence of trash and debris, vagrants/graffiti/vandalism (Photo D-5)**

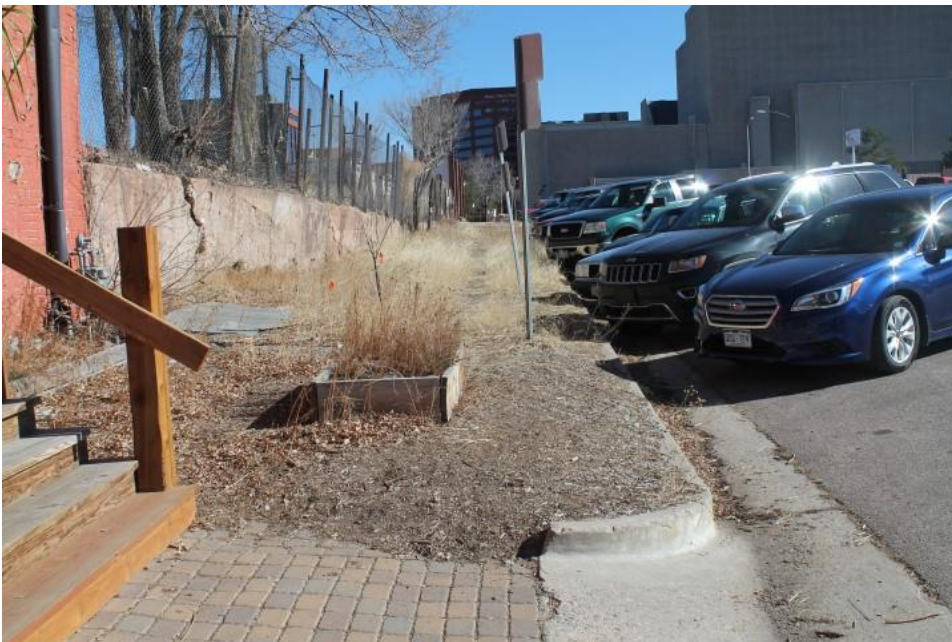
**Figure 2-11 Poor vehicle access, substandard driveway/curb cuts, cracked or uneven pedestrian surfaces, unsafe level changes, inadequate and deteriorated sidewalk, presence of trash and debris, unsafe level changes, inadequate site maintenance, non-conformance to development regulations, deteriorated site walls (Photo D-10)**

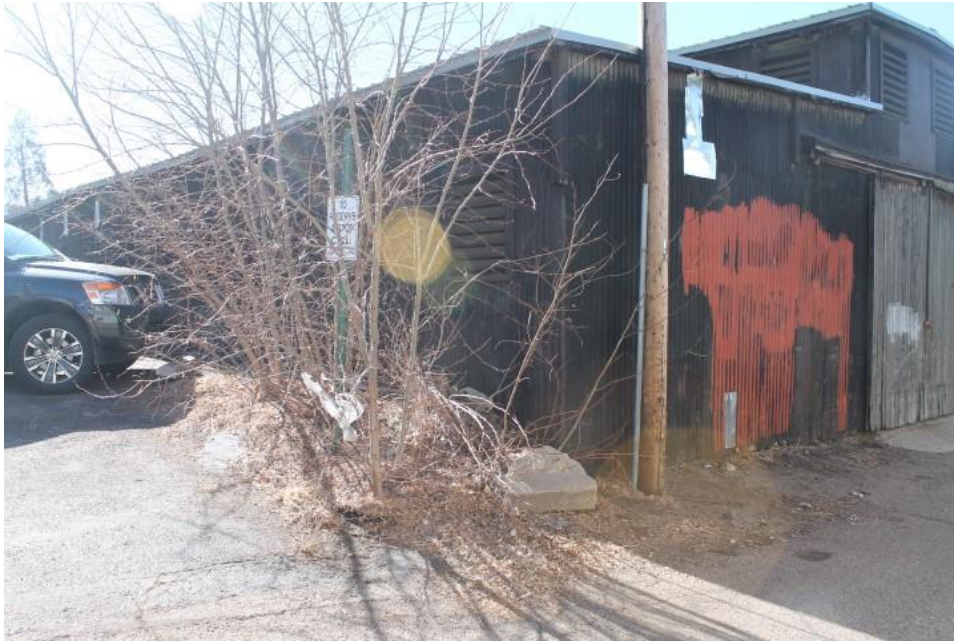
**Figure 2-12 Deteriorated exterior walls, deteriorated fascia/eaves, lack of gutters/downspouts, vagrants/graffiti/vandalism, inadequate site maintenance, non-conformance to site development regulations (Photo E-1)**

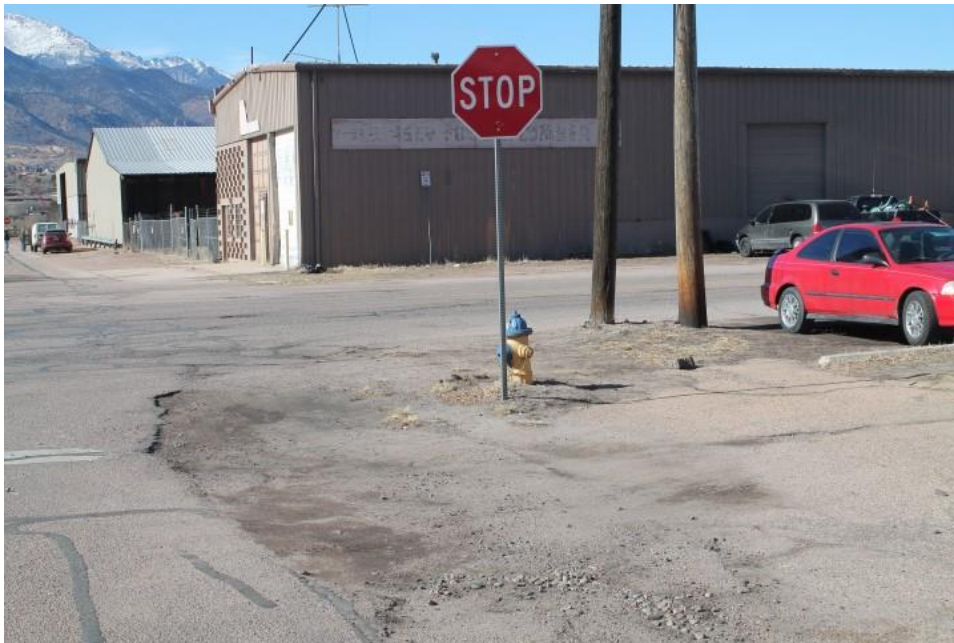
**Figure 2-13 Poor vehicle access, lack of parking lot pavement, substandard driveway/curb cuts, cracked and uneven surfaces, unsafe level changes, deteriorated curb and gutter, inadequate and deteriorated sidewalk, non-conformance to development regulations (Photo E-4)**
