**Conditions Study for  
Park Union Study Area  
Colorado Springs, Colorado**

DRAFT

February 2022

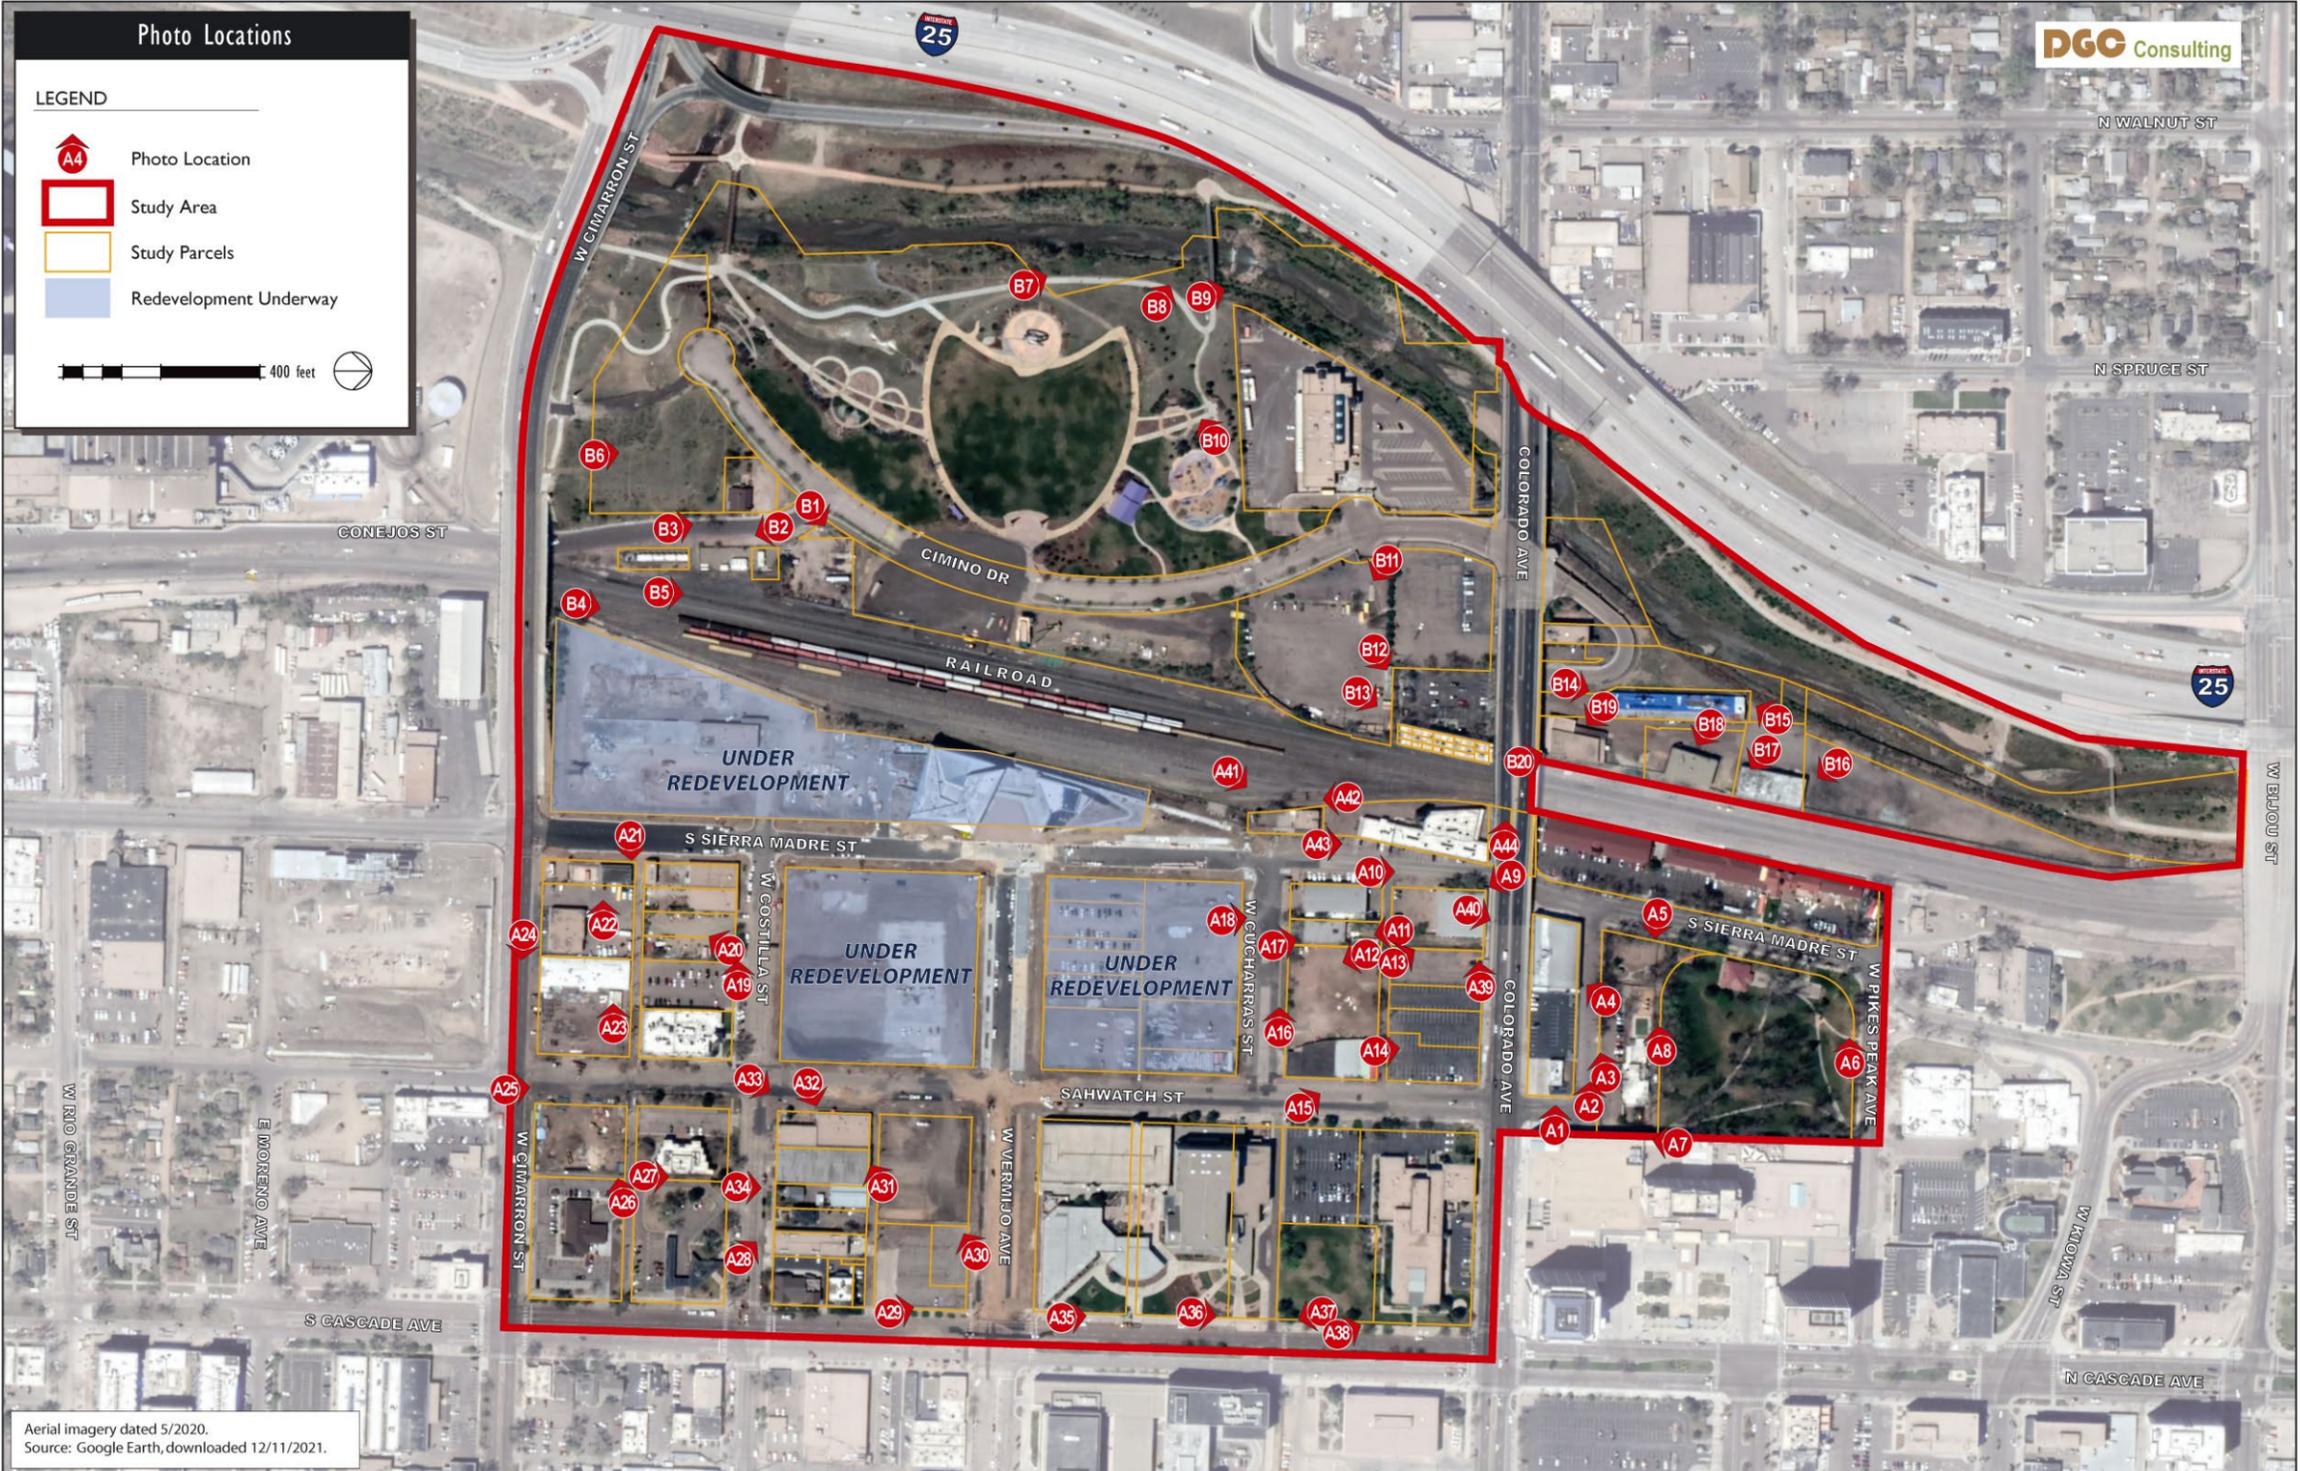
Exhibit 3-1: Field Survey Photo-Reference Map

The blight factors observed are documented on Exhibit 3-1: Field Survey Photo Reference Map and Table 3-1 to 3-2: Photographic/Desktop Analysis Reference Sheet. A complete set of survey photographs is included in Exhibit 3-2: Field Survey Photographs Subareas A - B.
